**DEVELOPMENT OF  $\text{Al}_2\text{O}_3$  -  $\text{Sm}_2\text{SrAl}_2\text{O}_7$  CERAMIC  
COMPOSITE THERMAL BARRIER COATINGS FOR  
HIGH TEMPERATURE APPLICATIONS**

Thesis

**Department of Metallurgical and Materials Engineering  
NATIONAL INSTITUTE OF TECHNOLOGY, KARNATAKA  
SURATHKAL, MANGALORE – 575025**

**July, 2023**

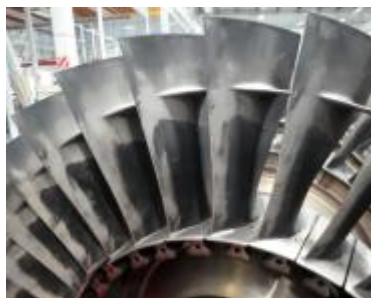
Figure 1.2 Corrosive deposits on compressor blade (Aust and Pons, 2019)

The hot corrosion in a gas turbine is the chemical attack of the component surface by corrosive salts such as  $\text{Na}_2\text{SO}_4$ ,  $\text{V}_2\text{O}_5$ , and  $\text{NaCl}$ , emerging from the low-quality fuels used in the system, which gets deposited on the component surface as shown in Figure 1.2. At high temperatures, the low melting corrosives tend to infiltrate the coatings. The conventional TBC systems, such as Ytria Stabilized Zirconia (YSZ) suffer from phase transformations and destabilization in the presence of corrosives. The coatings may present a porous structure with cracks after exposure to hot corrosion conditions. The resistance of a system towards hot corrosion depends on the overall chemistry, reactivity, high-temperature stability, and surface conditions of the coating.

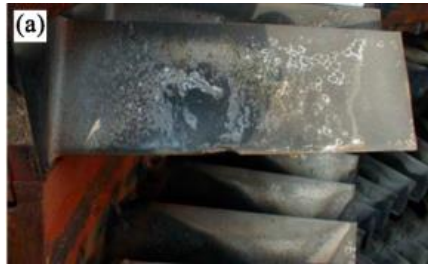
Figure 1.3 Erosion on leading edge of a turbine fan blade (Alqallaf et al. 2020)

The erosion in a gas turbine is the surficial material removal by the impact of solid particles embedded in the inlet gas stream. Figure 1.3 shows the erosion on the leading edge of a turbine fan blade. The succession of impacts leads to material removal from

the surface, leading to component failure. The resistance against high-temperature erosion depends on the surface properties and mechanical properties of the system. A surface with high hardness is recognized to offer better erosion resistance (Alqallaf et al. 2020; Aust and Pons 2019; Puspitasari et al. 2021).

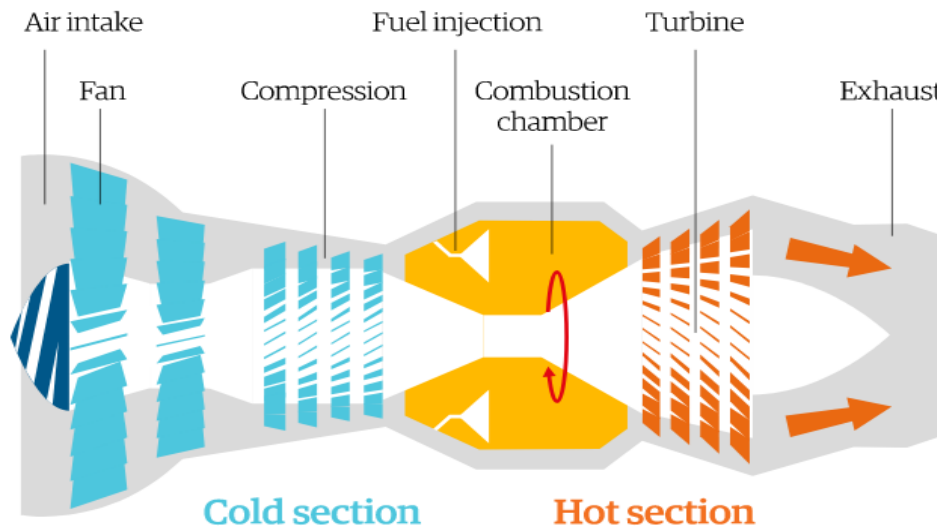
Figure 2.2 The cross section of interior of a jet engine showing the hot section parts (Guardian Graphics)

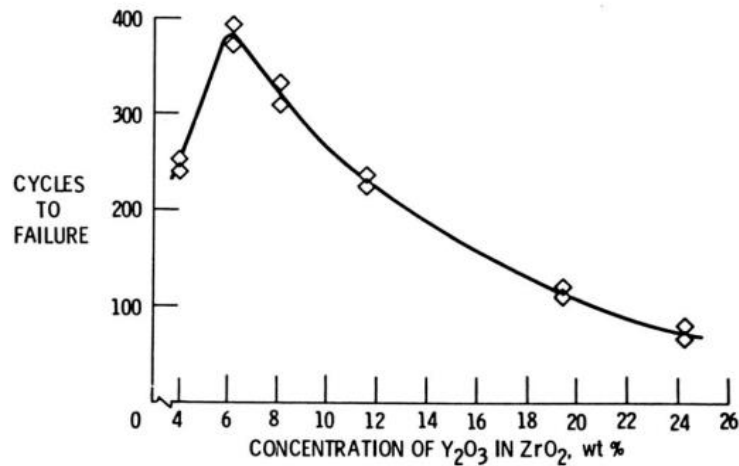
Figure 2.4 Performance variation of  $ZrO_2$  with different composition of  $Y_2O_3$  (Stecura, 1985)

The initial top coats used for thermal insulation were flame sprayed zirconia-calcia coatings. The zirconia-based coatings tend to destabilize upon exposure to high temperatures. Later,  $ZrO_2$ - $Y_2O_3$  ceramic applied on NiCrAlY bond coat was used by National Aeronautics and Space Administration (NASA) Lewis research center, where the yttria stabilizes the zirconia. From the different weight percentages of  $Y_2O_3$  addition varying from 12-20 %, Stecura (1985) proved that a 6-8 %  $Y_2O_3$  produces better results in thermal cycling as shown in Figure 2.4 (Stecura 1985; Miller 1997).

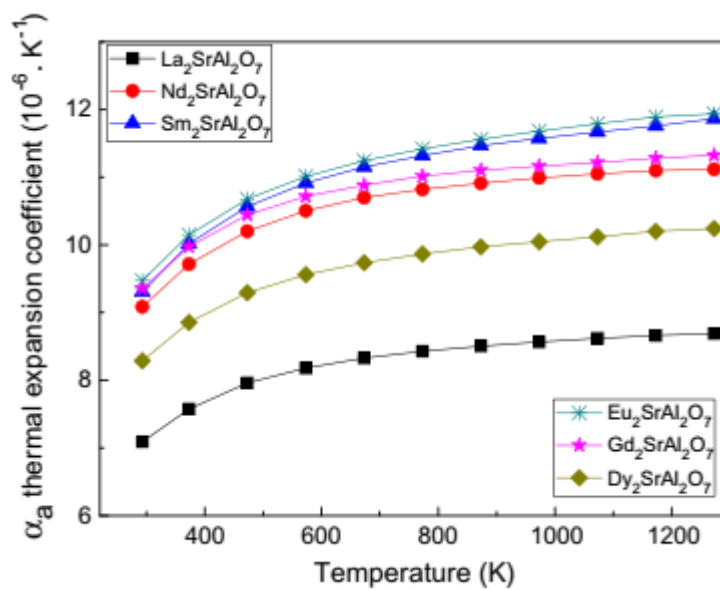
Figure 2.5 Thermal expansion coefficients of different rare earth aluminates (Feng et al., 2012)

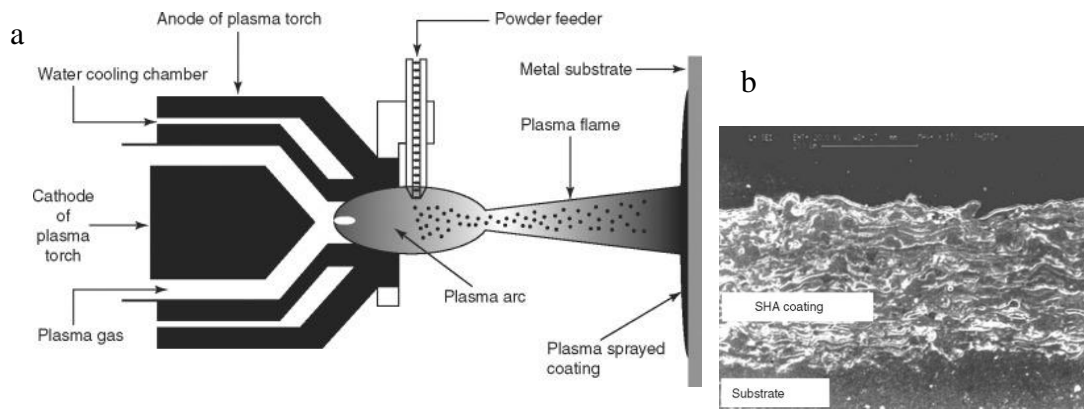
Figure 2.8 a) Schematic of APS process and b) microstructure developed through APS (Wang et al., 2015)

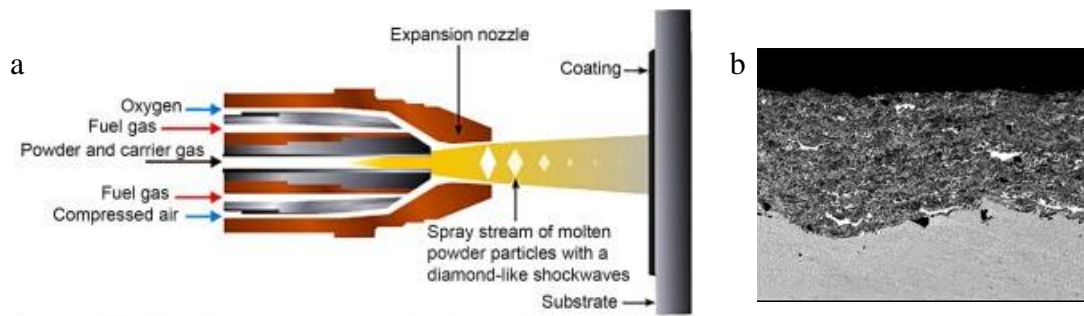
Figure 2.9 a) Schematic of HVOF process and b) microstructure developed through HVOF (Eskandarany, 2020)

surface may have unmolten particles if the larger powder particles do not achieve sufficient temperature upon flight. The schematic of the process and the general microstructure is shown in Figure 2.9.

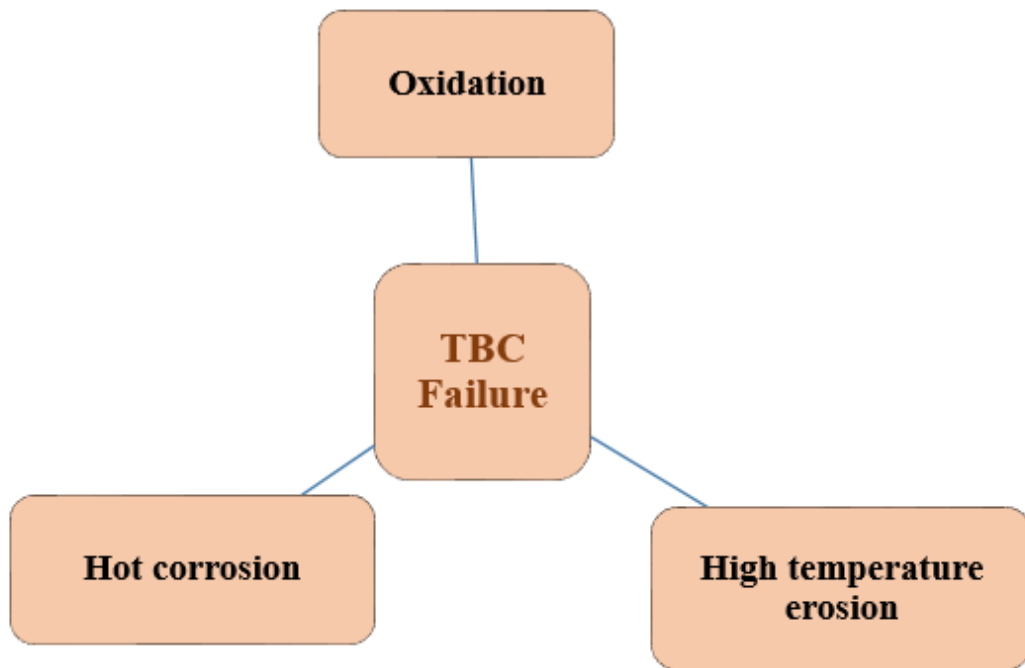
Figure 2.10 Major failure modes in TBCs

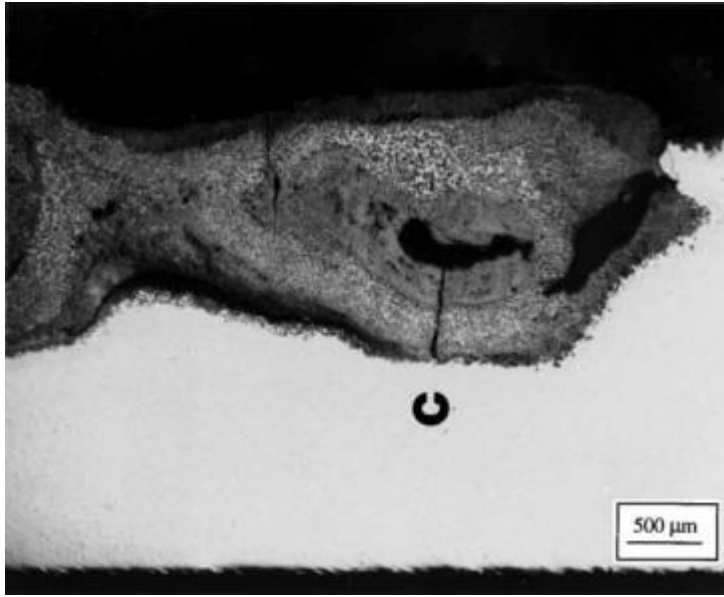
Figure 2.11 The hot corrosion attack on a turbine blade (Eliaz et al.,2002)

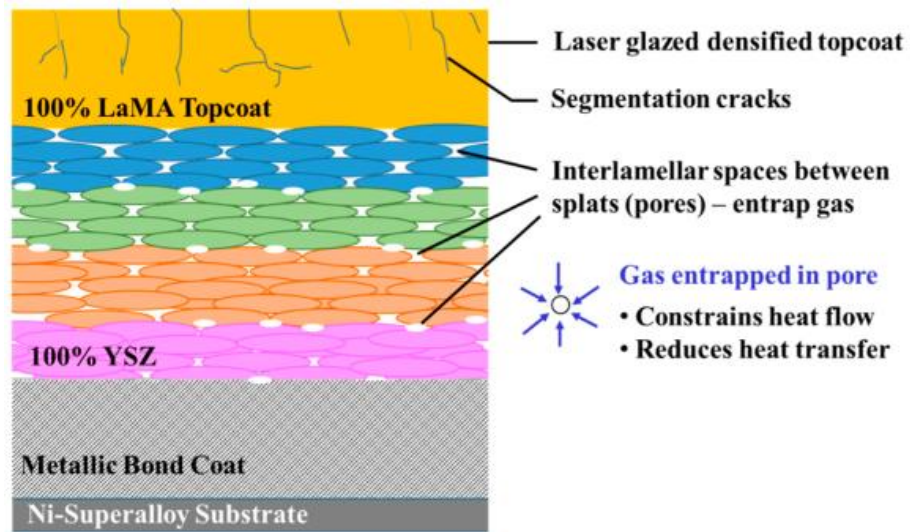
Figure 2.13 Schematic of densification of top coat by laser- treatment in a YSZ-Lanthanum hexa-aluminate gradient coating (Khan et al., 2021)

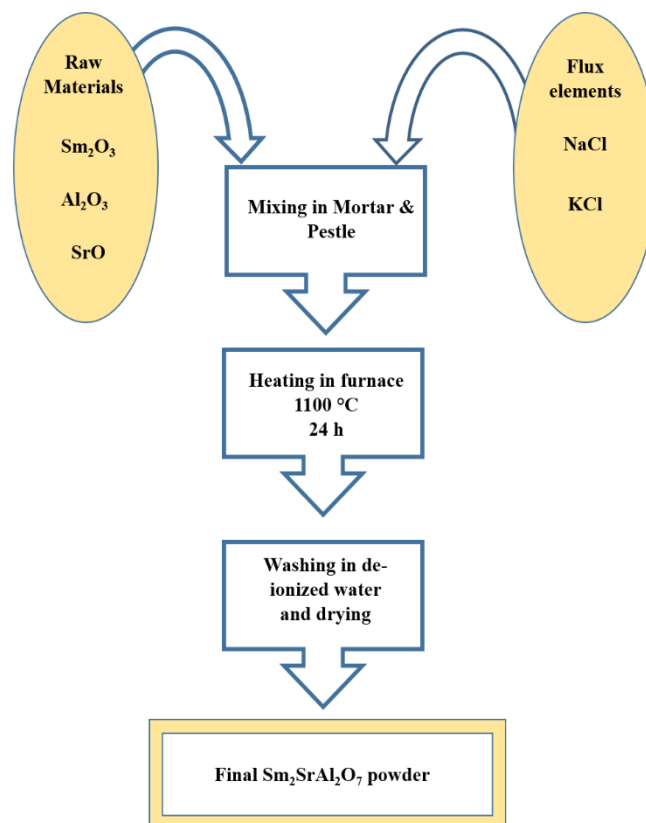
Figure 3.1 Flowchart of  $\text{Sm}_2\text{SrAl}_2\text{O}_7$  synthesis

The rare earth ceramic samarium strontium aluminate (SSA) was synthesized via molten salt synthesis technique from the precursor components  $\text{Sm}_2\text{O}_3$ ,  $\text{SrO}$ , and  $\text{Al}_2\text{O}_3$ . The flowchart of the synthesis process is shown in Figure 3.1.

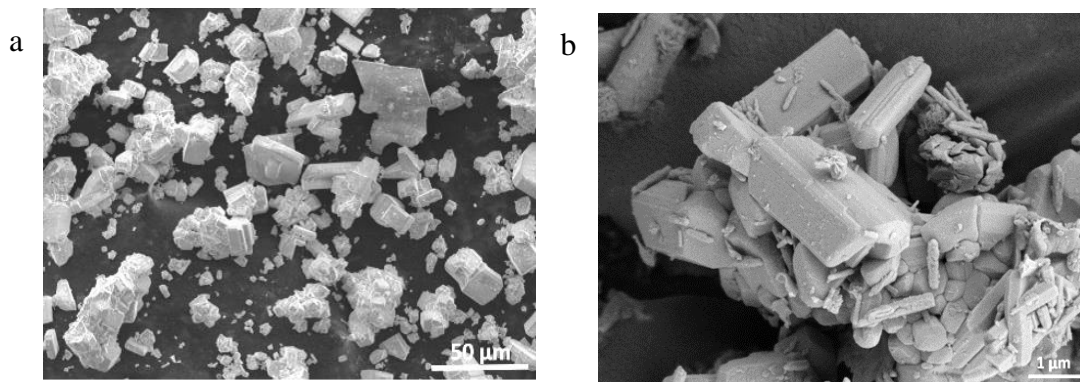
Figure 4.1 The morphology of synthesized SSA powder in a) low and b) high magnifications

The morphology of the developed  $\text{Sm}_2\text{SrAl}_2\text{O}_7$  powder at different magnifications is shown in Figure 4.1. The SSA particles showcased a cuboidal shape with an average particle size of 30  $\mu\text{m}$ . A cuboidal shape was observed in fused and crushed powders and is susceptible to lower flowability concerns. In the developed powder, the product lumps were crushed and washed, leading to the observed particle shape. The spherical powders were preferred to ensure uninterrupted feeding and to avoid the clogging of particles upon injection. On the other hand, a non-spherical particle has a lower elastic rebounding tendency, in case of a partial or unmolten impact on the substrate (Nouri and Sola 2019).

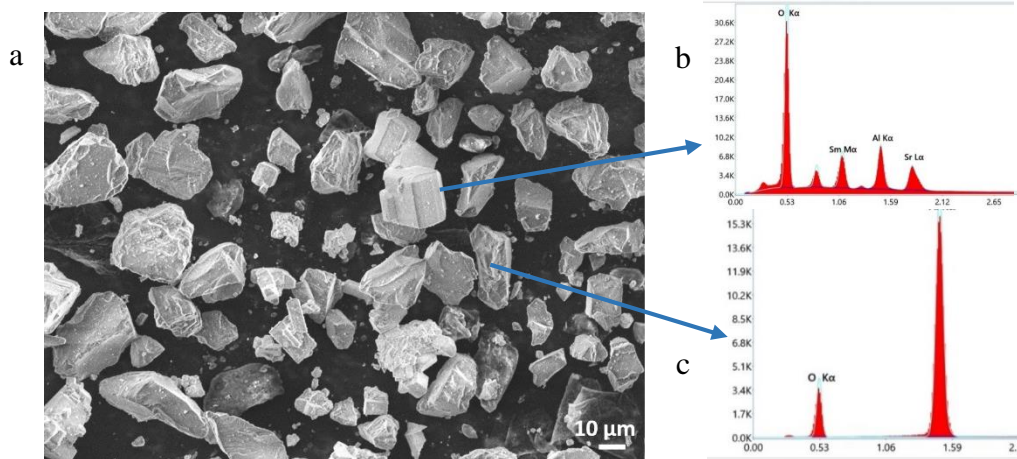
Figure 4.7 a) SEM image of the composite mixture b), c) EDS analysis of SSA and alumina particle in the composite mixture respectively

The composite powder for the top coat was prepared by thoroughly mixing the alumina and SSA powder in a 70:30 weight ratio. Figure 4.7 shows the distribution and EDS composition of the powder particles in the prepared mixture. Powder particle shapes and corresponding compositions have been confirmed through EDS analysis, as shown in Figure 4.7-b and Figure 4.7-c. The flowability of the feedstock powder influences the coating process and the resulting microstructure. The flowability of the composite powder mixture was found using the Hall Flowmeter Funnel test according to ASTM B-213 standard test method. The composite powder was found to flow continuously, while the pure SSA powder was not flowing through the orifice due to interparticle friction. The addition of alumina have aided flowability to the composite system.

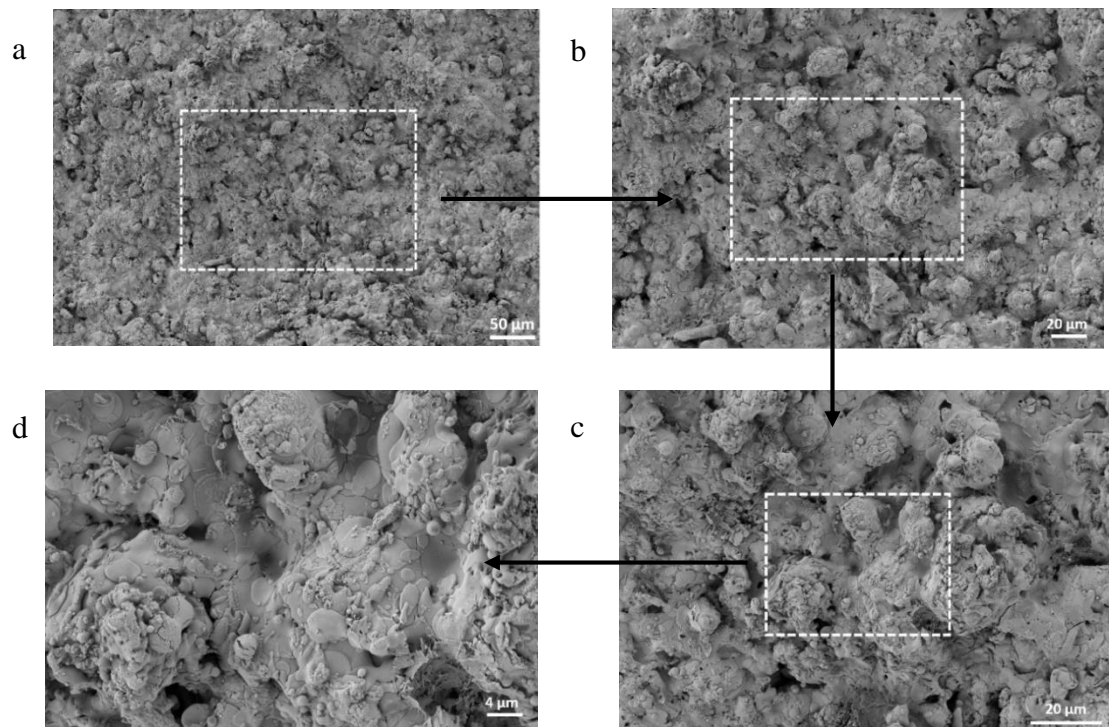
Figure 4.8 The surface of as-coated specimen viewed in SEM at different magnifications

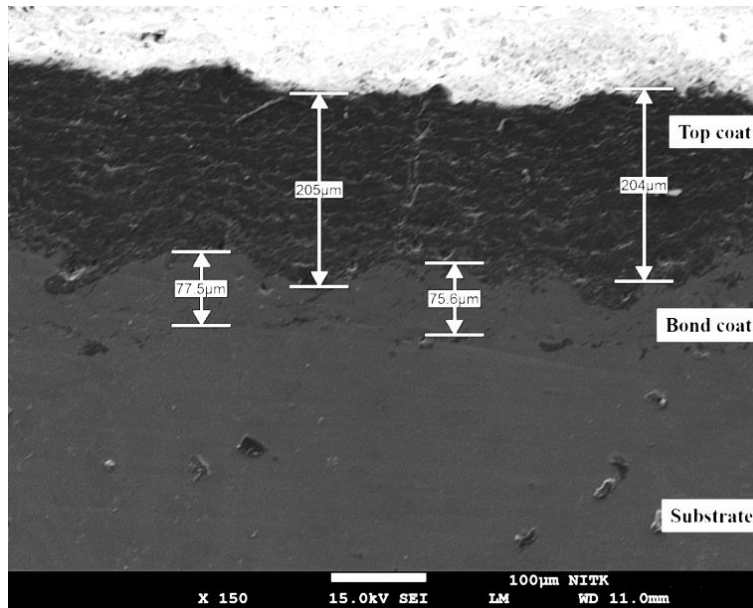
Figure 4.9 Cross-section of the developed TBC observed under SEM

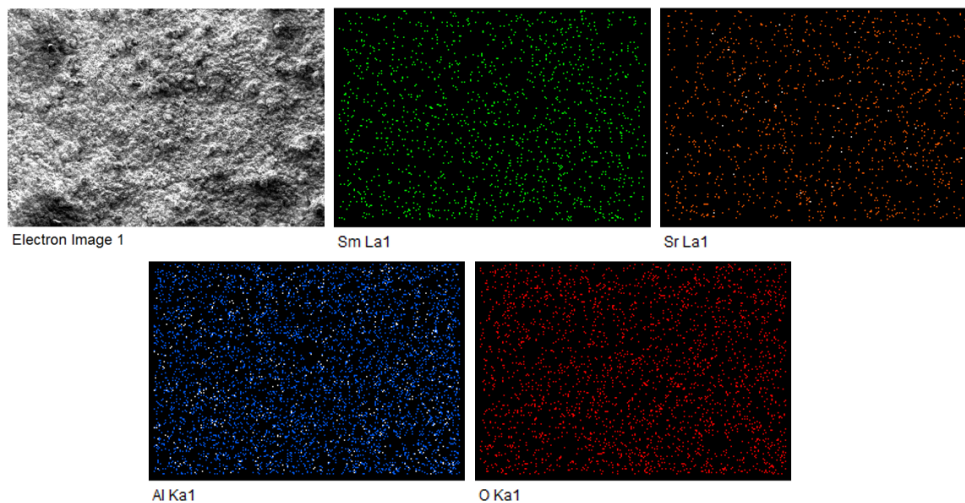
Figure 4.10 Elemental mapping of as-coated surface

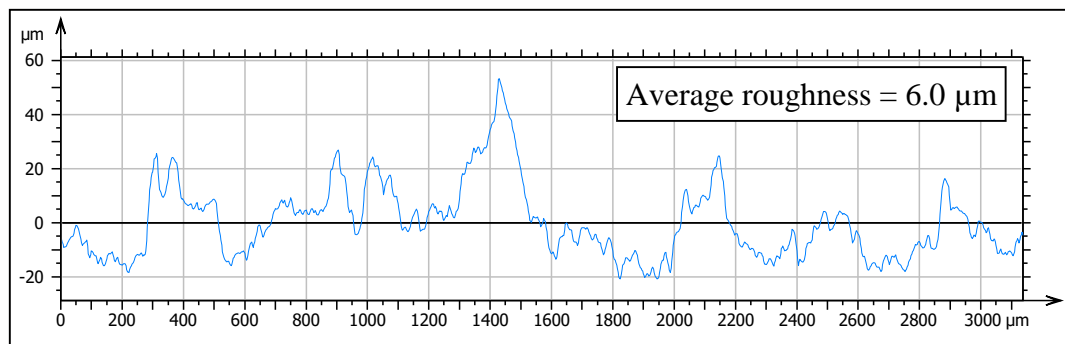
Figure 4.11 Surface roughness profile and profilometric image of as-coated sample

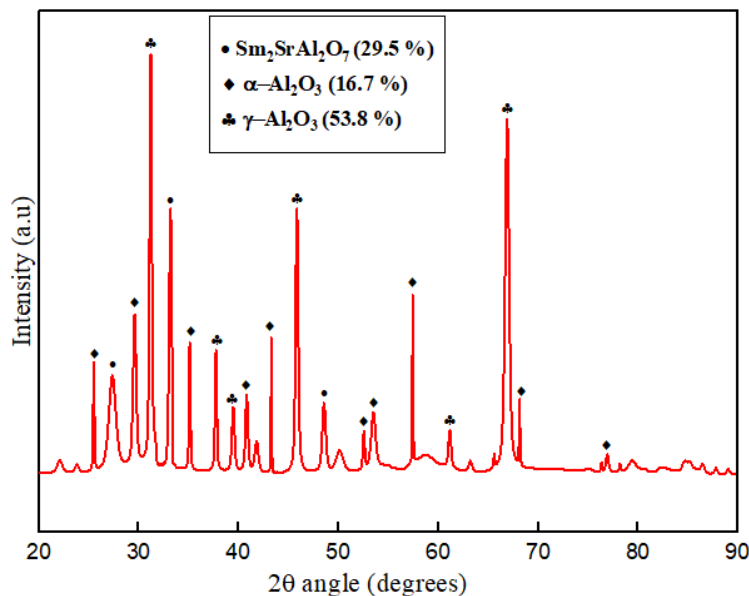
Figure 4.12 XRD pattern of the as-coated composite sample surface

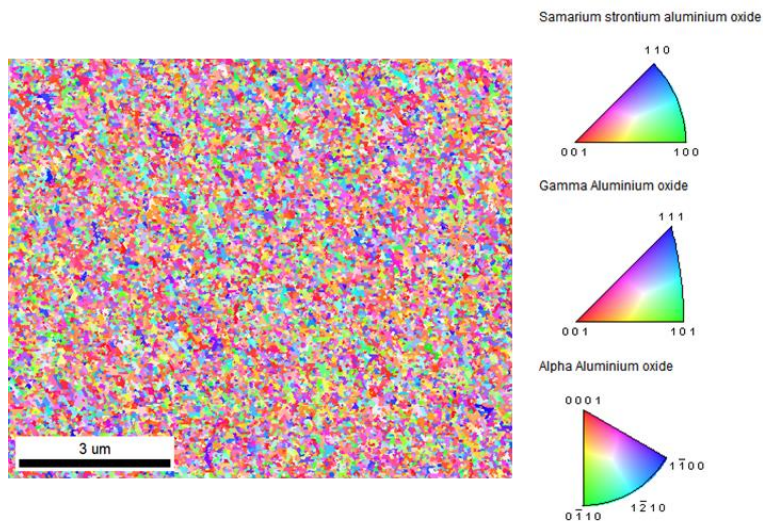
Figure 4.14 Inverse pole figure of as-coated samples

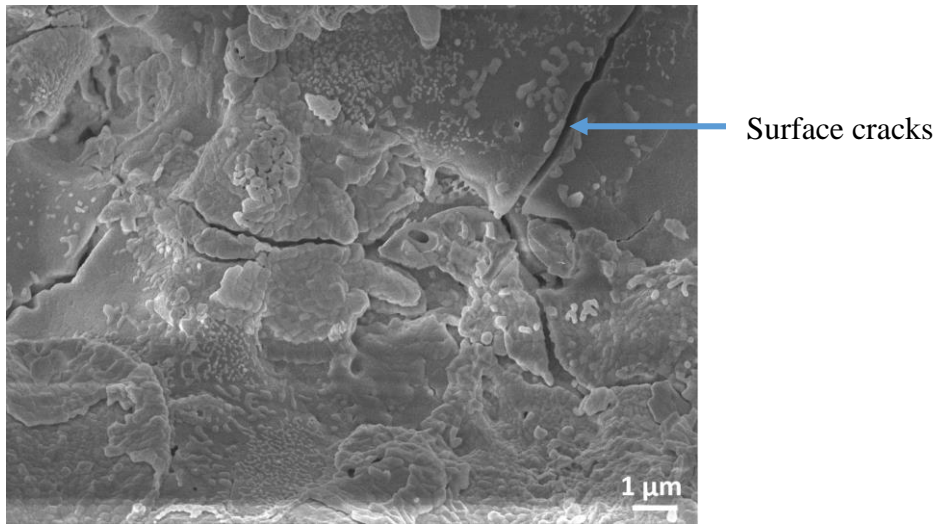
Figure 5.2 Magnified surface image of as-coated samples after oxidation test at 1100 °C for 150 h

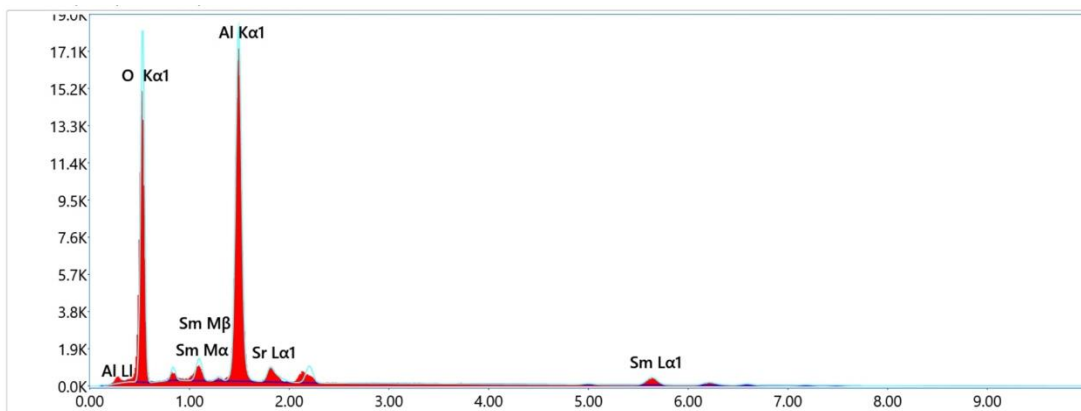
Figure 5.3 EDS analysis of the surface after exposure at 1100 °C for 150 h

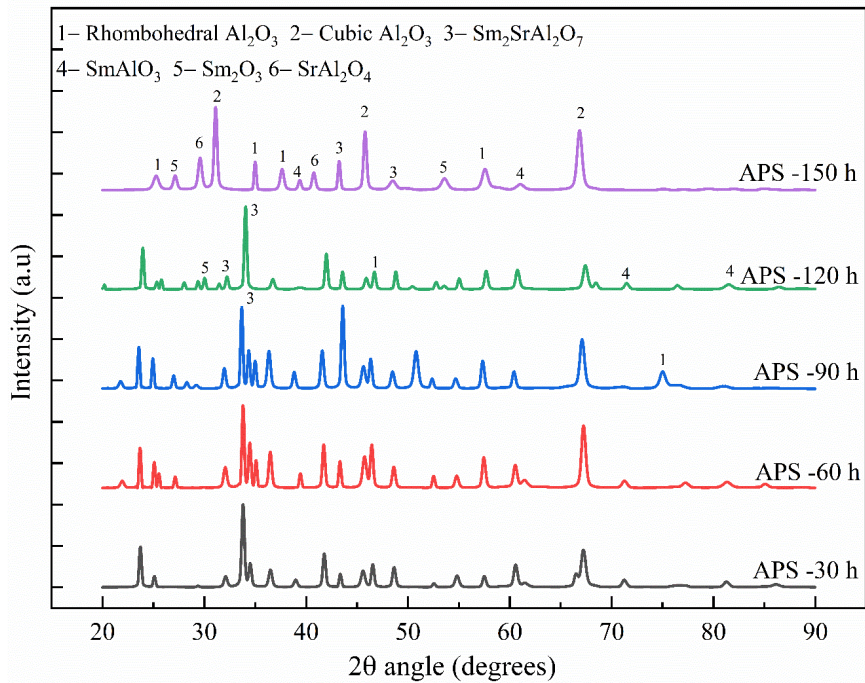
Figure 5.4 XRD patterns of as-coated samples after oxidation for different durations

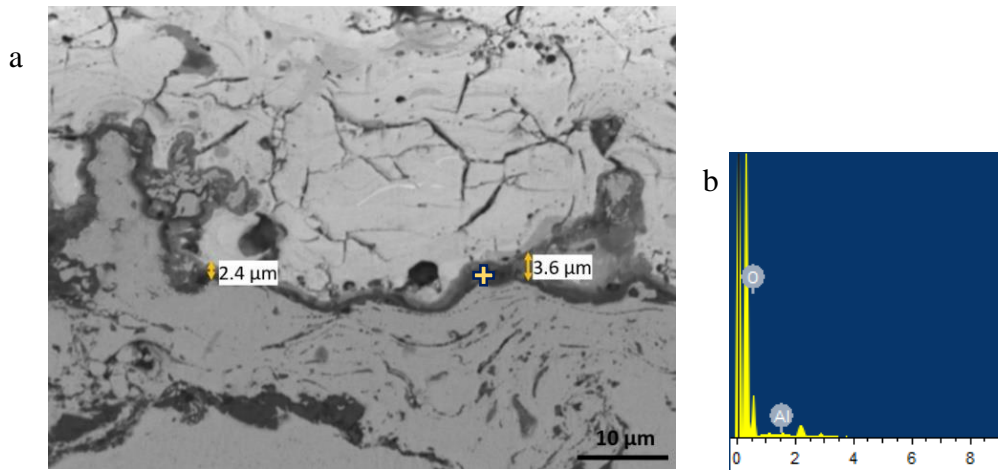
Figure 5.5 a) Cross-section of developed coatings exposed to 30 h oxidation at 1100 °C, b) EDS mapping of TGO region

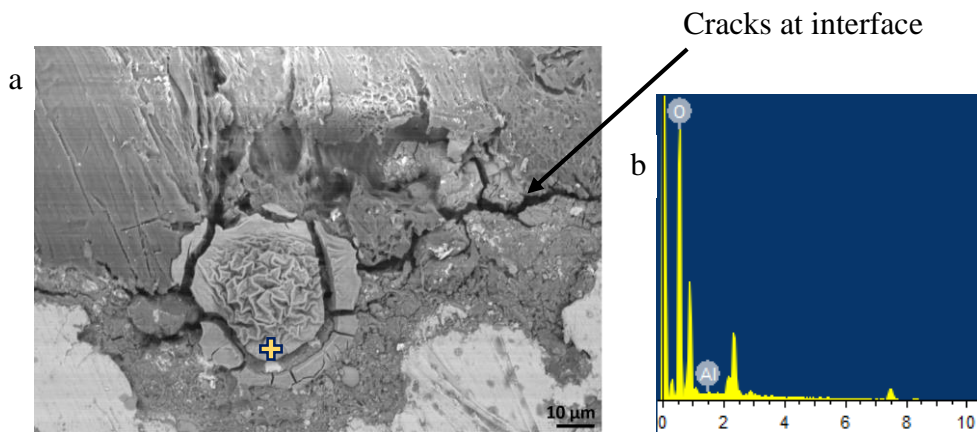
Figure 5.8 a) High magnification view of lump formation at interface of as-coated sample after oxidation tests b) EDS analysis of lump

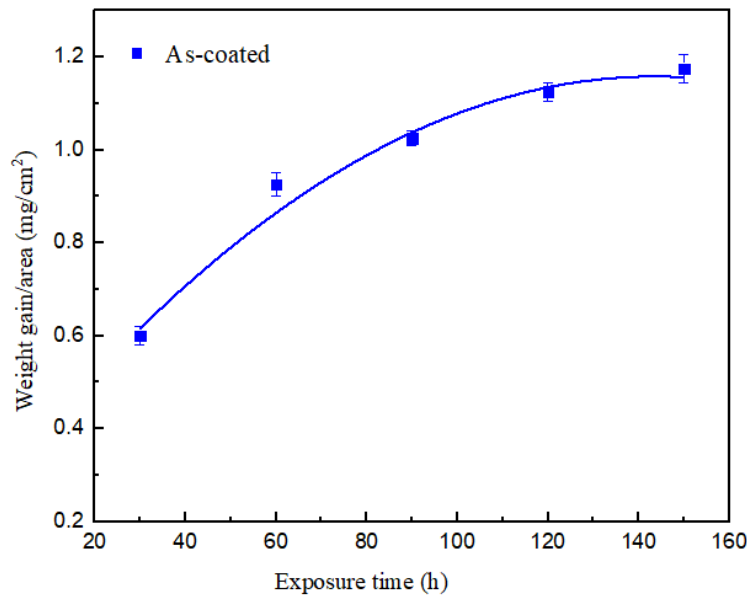
Figure 5.9 Weight gain per unit area of as-coated samples exposed to oxidation test at 1100 °C for different durations

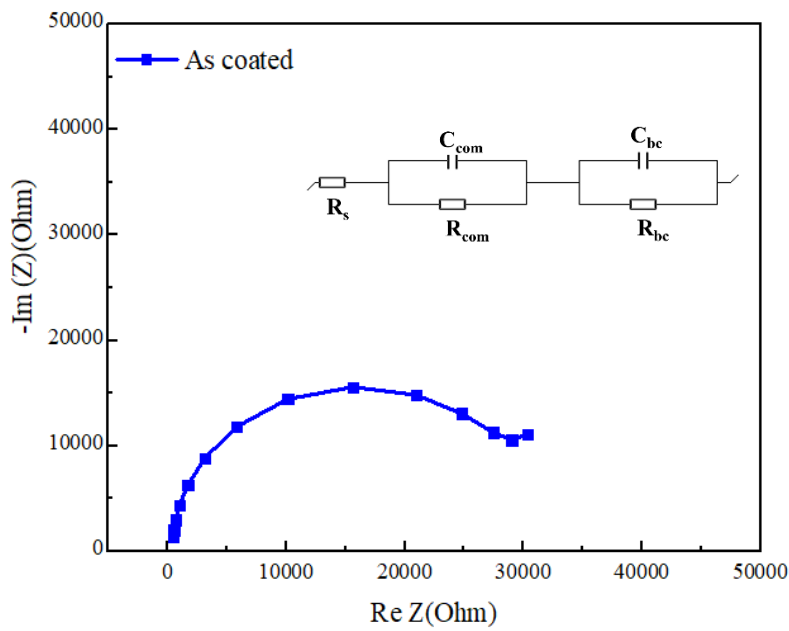
Figure 5.11 EIS Nyquist plot of as-coated samples

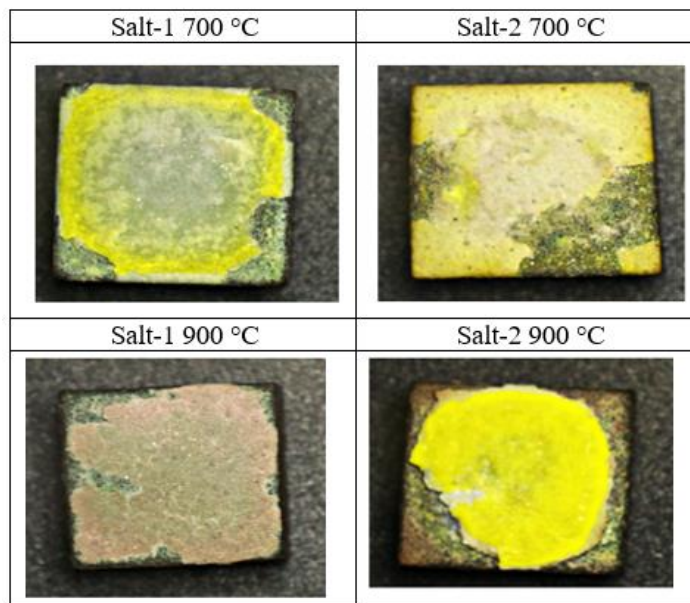
Figure 5.13 Photographs of as-coated samples after hot corrosion in various conditions

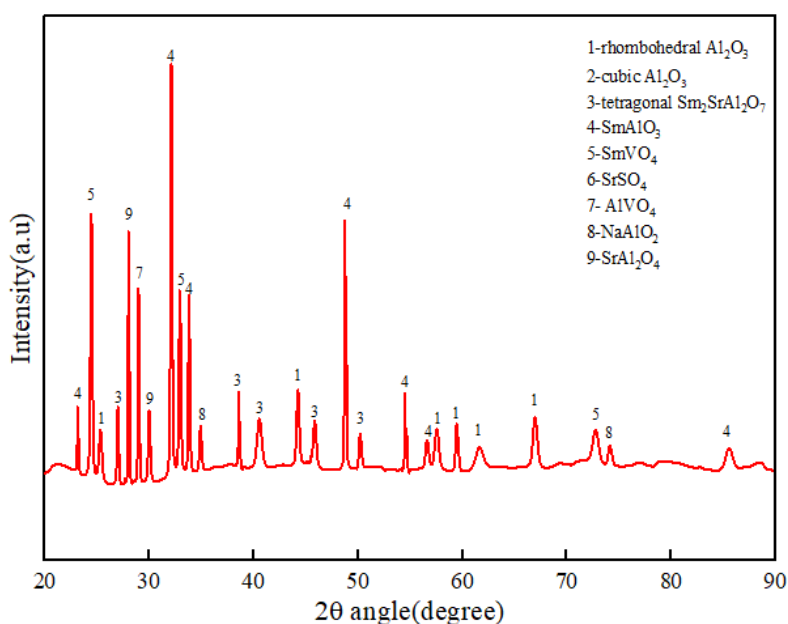
Figure 5.14 XRD pattern of as-coated sample exposed to 50 % wt  $\text{Na}_2\text{SO}_4$  + 50 % wt  $\text{V}_2\text{O}_5$  at 700 °C

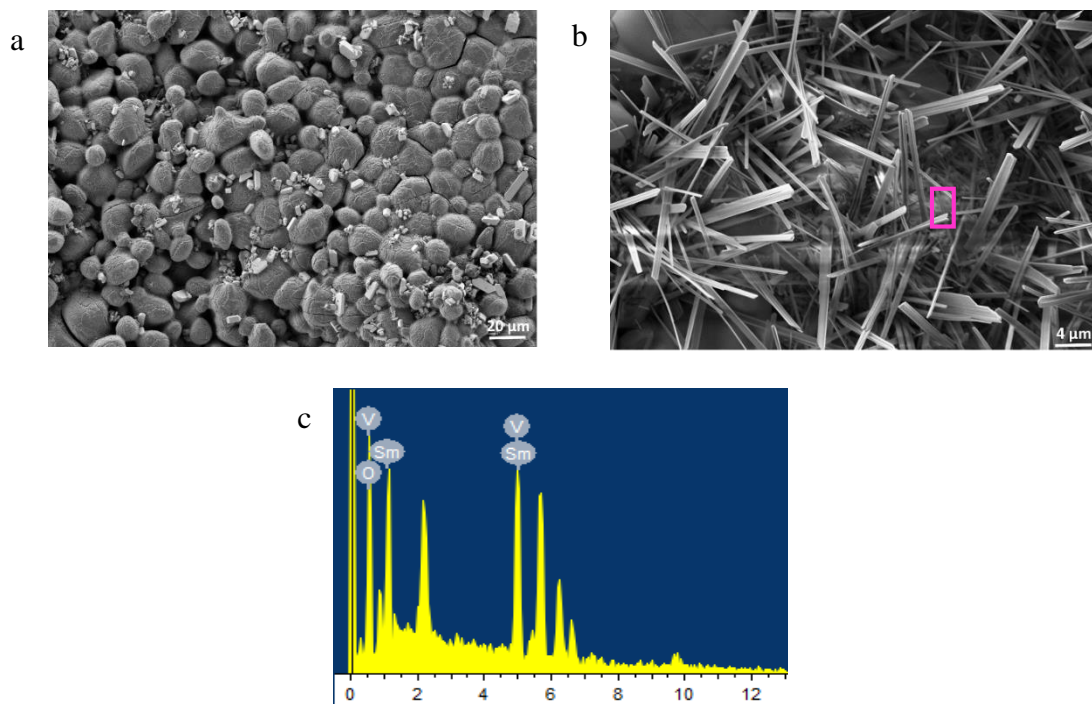
Figure 5.15 The SEM morphology of failed samples exposed to 50 % wt  $\text{Na}_2\text{SO}_4$  + 50 % wt  $\text{V}_2\text{O}_5$  at 700 °C showing  
 a) Low magnification image of corroded surface  
 b) High magnification image of the hot corrosion products formed on surface  
 c) EDS analysis of the corrosion products formed

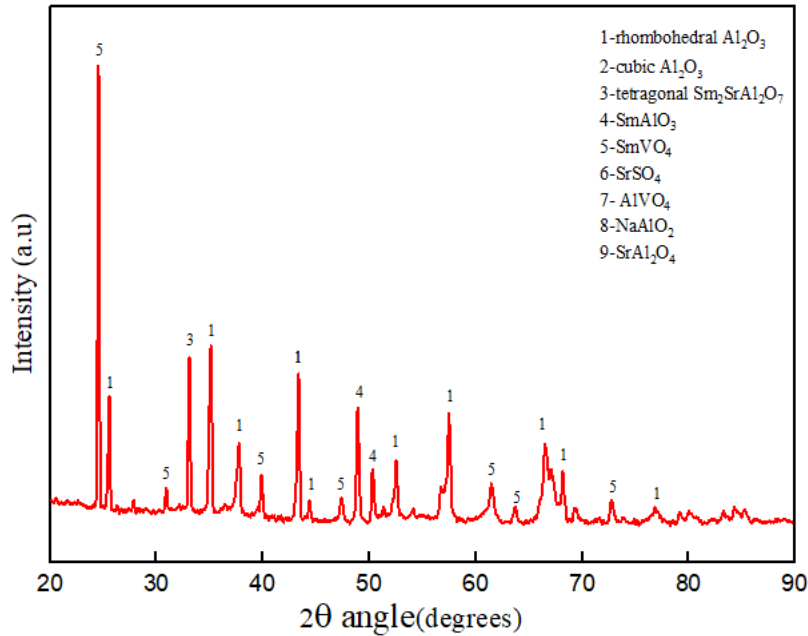
Figure 5.16 XRD pattern of sample exposed to 50 % wt  $\text{Na}_2\text{SO}_4$  + 50 % wt  $\text{V}_2\text{O}_5$  at 900 °C

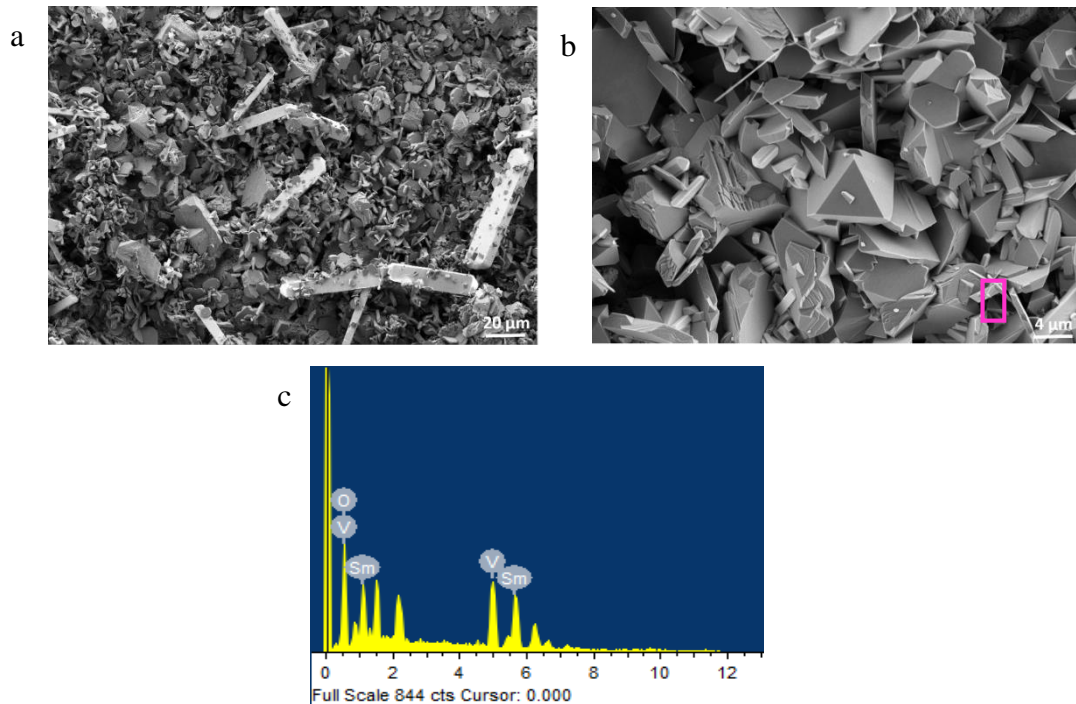
Figure 5.17 The SEM morphology of failed samples exposed to 50 % wt Na<sub>2</sub>SO<sub>4</sub> + 50 % wt V<sub>2</sub>O<sub>5</sub> at 900 °C showing  
 a) Low magnification image of corroded surface  
 b) High magnification image of the hot corrosion products formed on surface  
 c) EDS analysis of the corrosion products formed

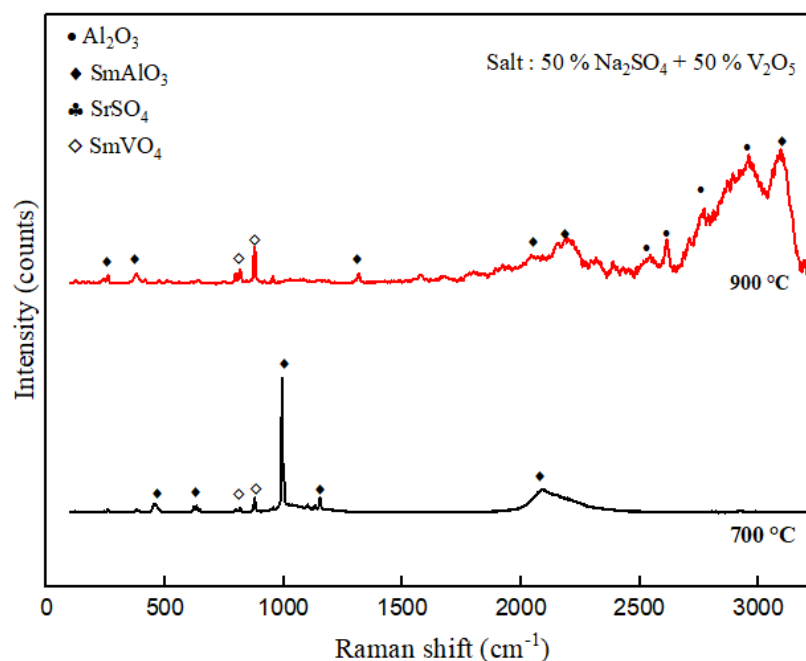
Figure 5.18 Raman spectrum of as-coated samples after hot corrosion tests at 50 % wt Na<sub>2</sub>SO<sub>4</sub> + 50 % wt V<sub>2</sub>O<sub>5</sub> at 700 °C and 900 °C

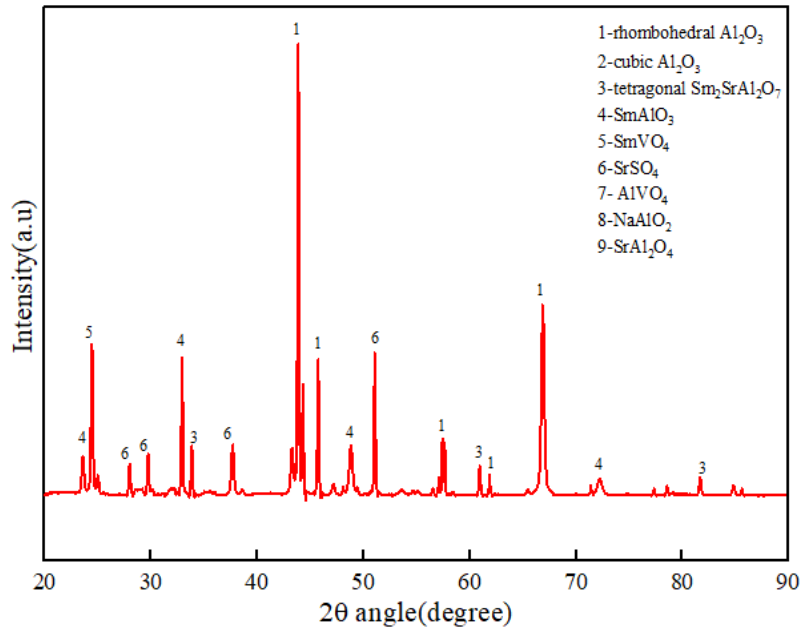
Figure 5.19 XRD pattern of sample exposed to 90 % wt  $\text{Na}_2\text{SO}_4$  + 5 % wt  $\text{V}_2\text{O}_5$  + 5 % wt  $\text{NaCl}$  at 700 °C

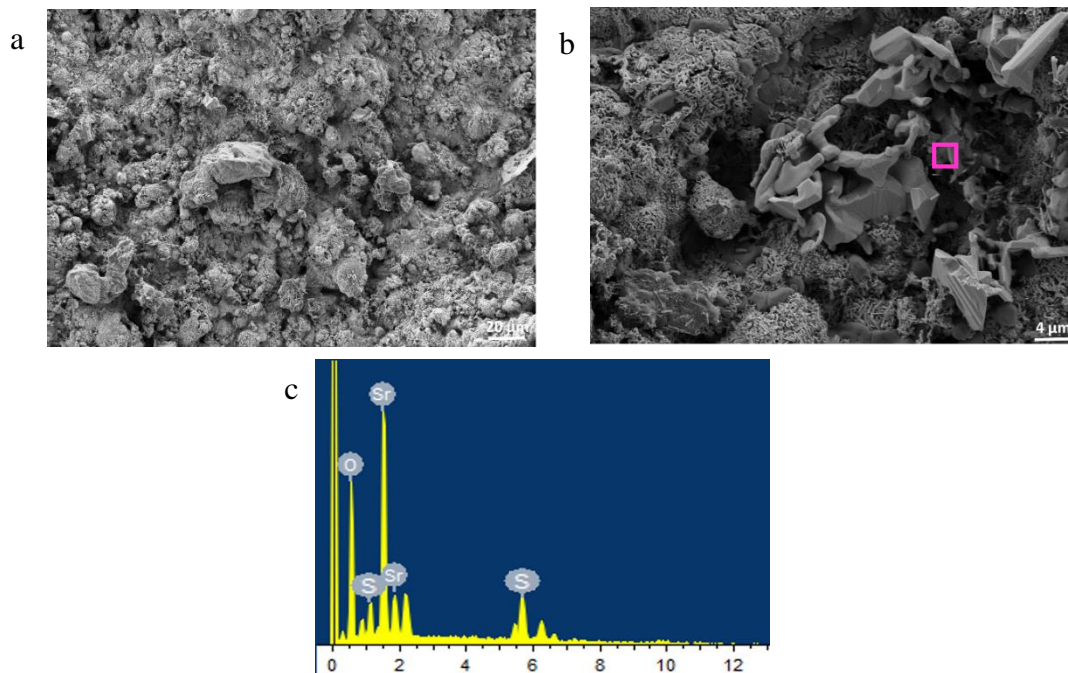
Figure 5.20 The SEM morphology of failed samples exposed to 90 % wt  $\text{Na}_2\text{SO}_4$  + 5 % wt  $\text{V}_2\text{O}_5$  + 5 % wt  $\text{NaCl}$  at 700 °C showing  
a) Low magnification image of corroded surface  
b) High magnification image of the hot corrosion products formed on surface  
c) EDS analysis of the corrosion products formed

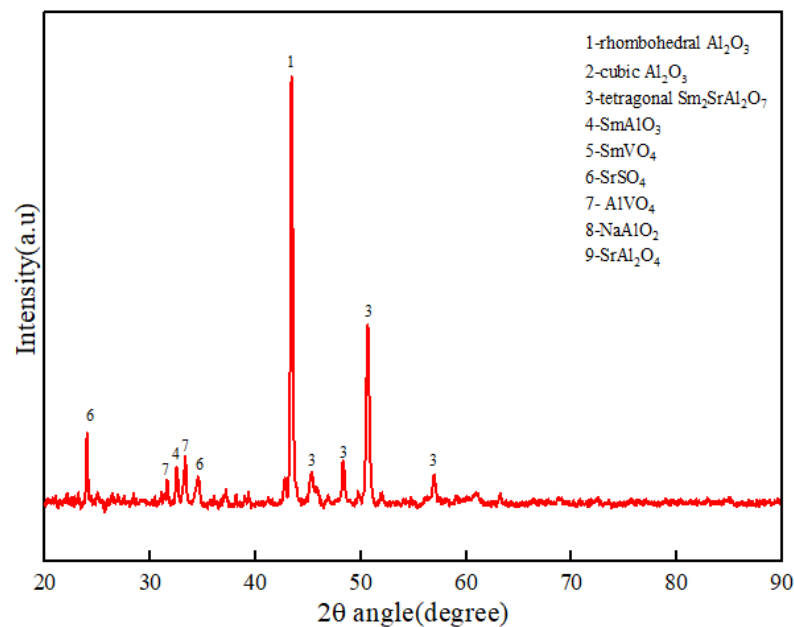
Figure 5.21 XRD pattern of sample exposed to 90 % wt Na<sub>2</sub>SO<sub>4</sub> + 5 % wt V<sub>2</sub>O<sub>5</sub> + 5 % wt NaCl at 900 °C

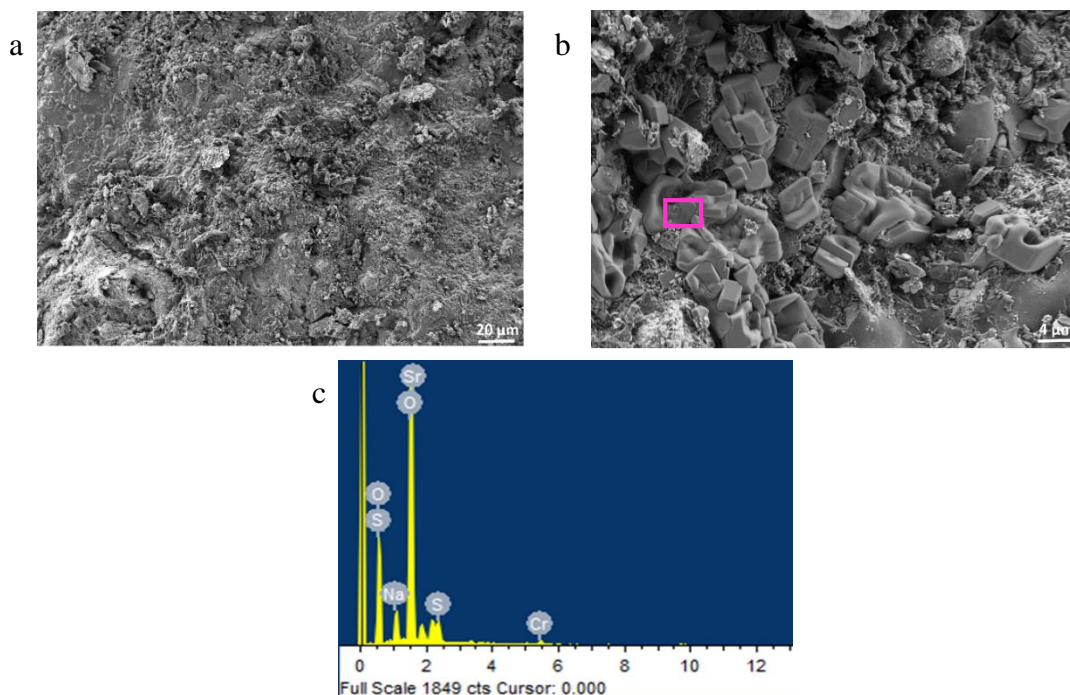
Figure 5.22 The SEM morphology of failed samples exposed to 90 % wt Na<sub>2</sub>SO<sub>4</sub> + 5 %wt V<sub>2</sub>O<sub>5</sub> + 5 %wt NaCl at 900 °C showing  
 a) Low magnification image of corroded surface  
 b) High magnification image of the hot corrosion products formed on surface  
 c) EDS analysis of the corrosion products formed

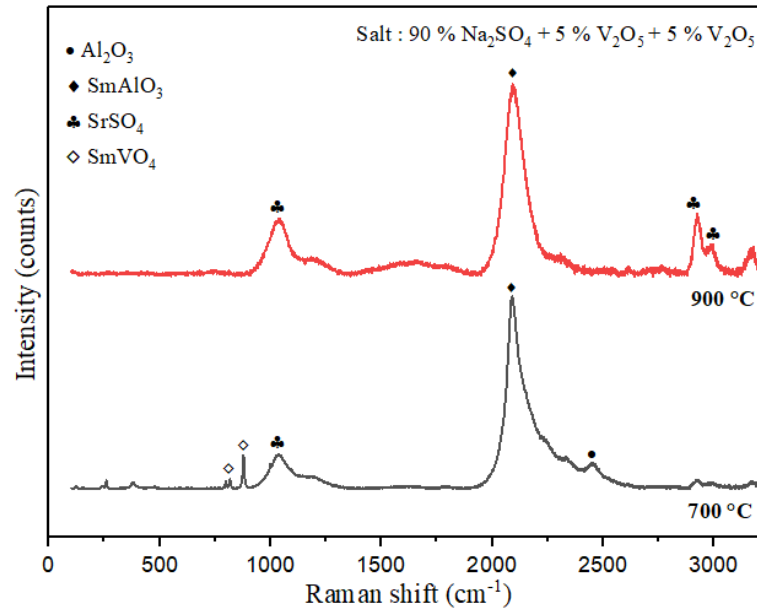
Figure 5.23 Raman spectrum of as-coated samples after hot corrosion tests at 90 wt Na<sub>2</sub>SO<sub>4</sub> + 5 wt V<sub>2</sub>O<sub>5</sub> + 5 wt NaCl at 700 °C and 900 °C

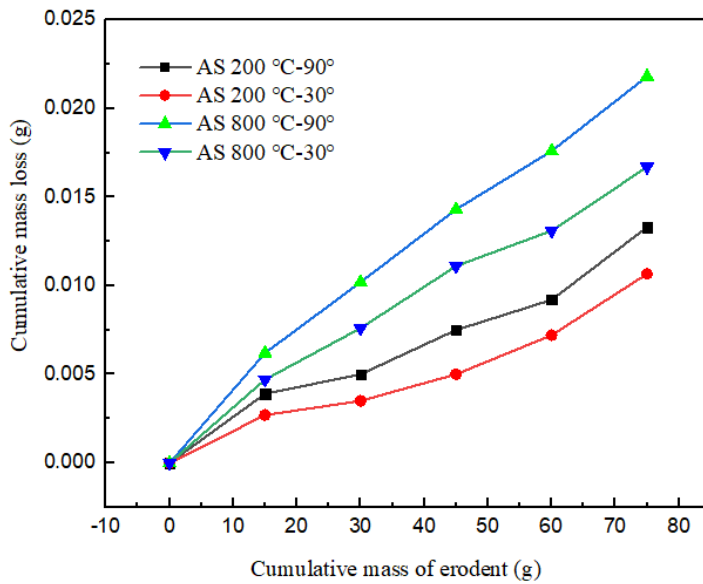
Figure 5.25 Graph showing cumulative mass loss of coating vs cumulative mass of erodents for as-coated samples subjected to various erosion conditions

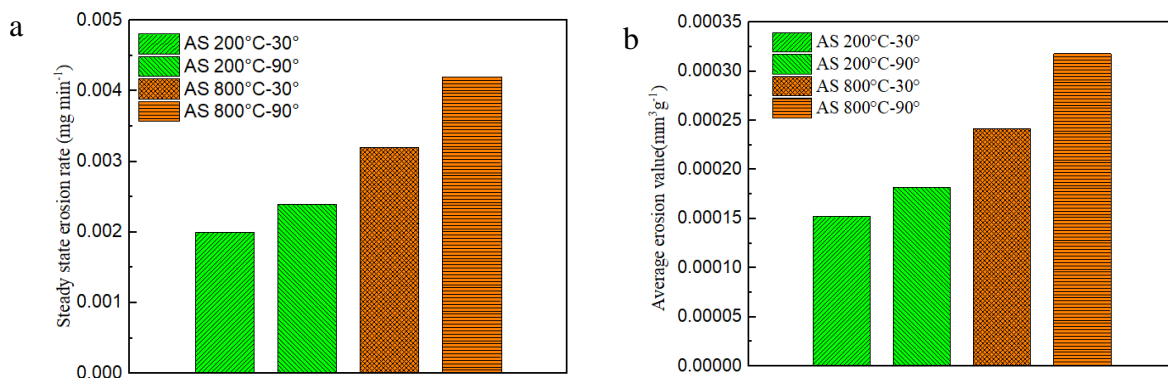
Figure 5.26 Plots showing a) steady state erosion rate and b) average erosion values of as-coated samples at different conditions

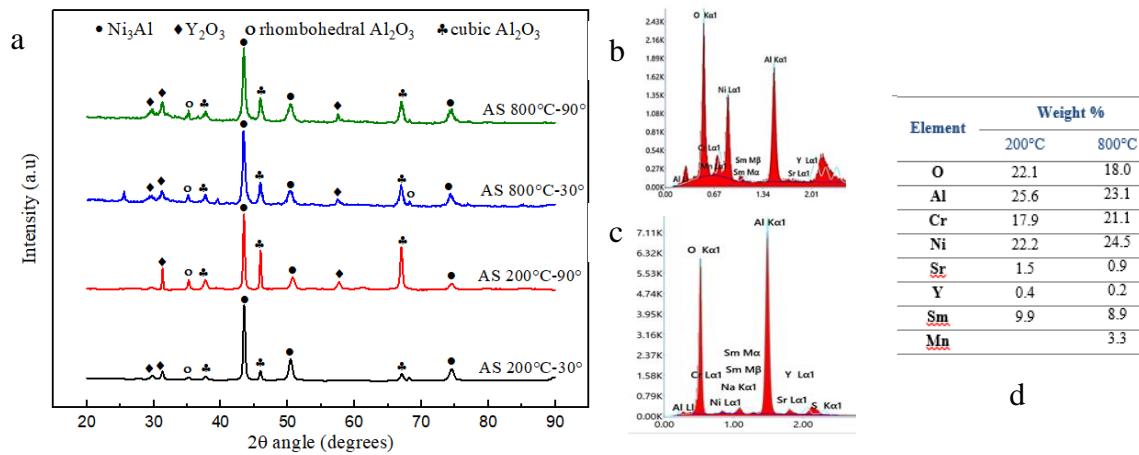
Figure 5.28 a) XRD patterns of scars of samples eroded at various conditions b) EDS composition of scar of samples exposed at 800 °C and c) 200 °C at 90° angle d) Nominal weight percentages observed in scars

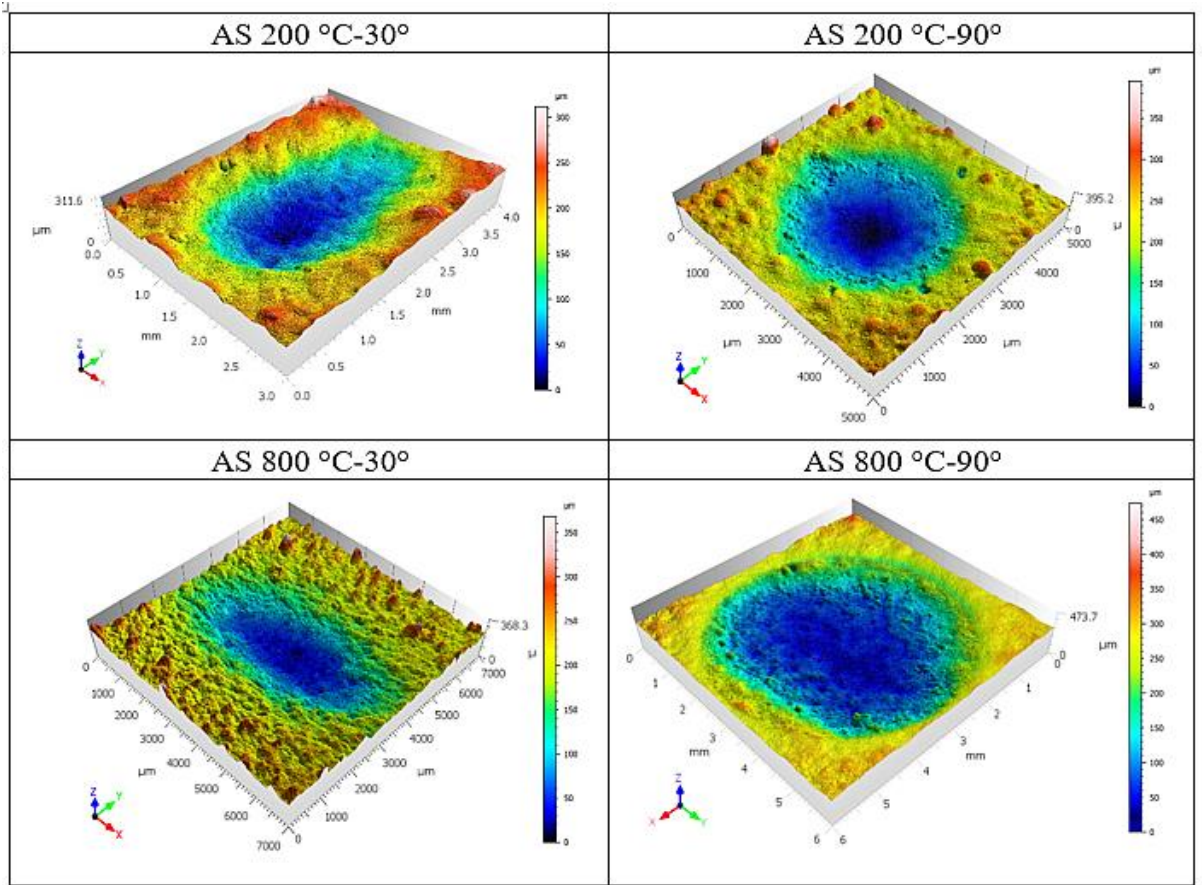
Figure 5.29 Profilometric images of erosion scars in as-coated samples subjected to erosion at different conditions
