**DEVELOPMENT OF  $\text{Al}_2\text{O}_3$  -  $\text{Sm}_2\text{SrAl}_2\text{O}_7$  CERAMIC  
COMPOSITE THERMAL BARRIER COATINGS FOR  
HIGH TEMPERATURE APPLICATIONS**

Thesis

**Department of Metallurgical and Materials Engineering  
NATIONAL INSTITUTE OF TECHNOLOGY, KARNATAKA  
SURATHKAL, MANGALORE – 575025**

**July, 2023**

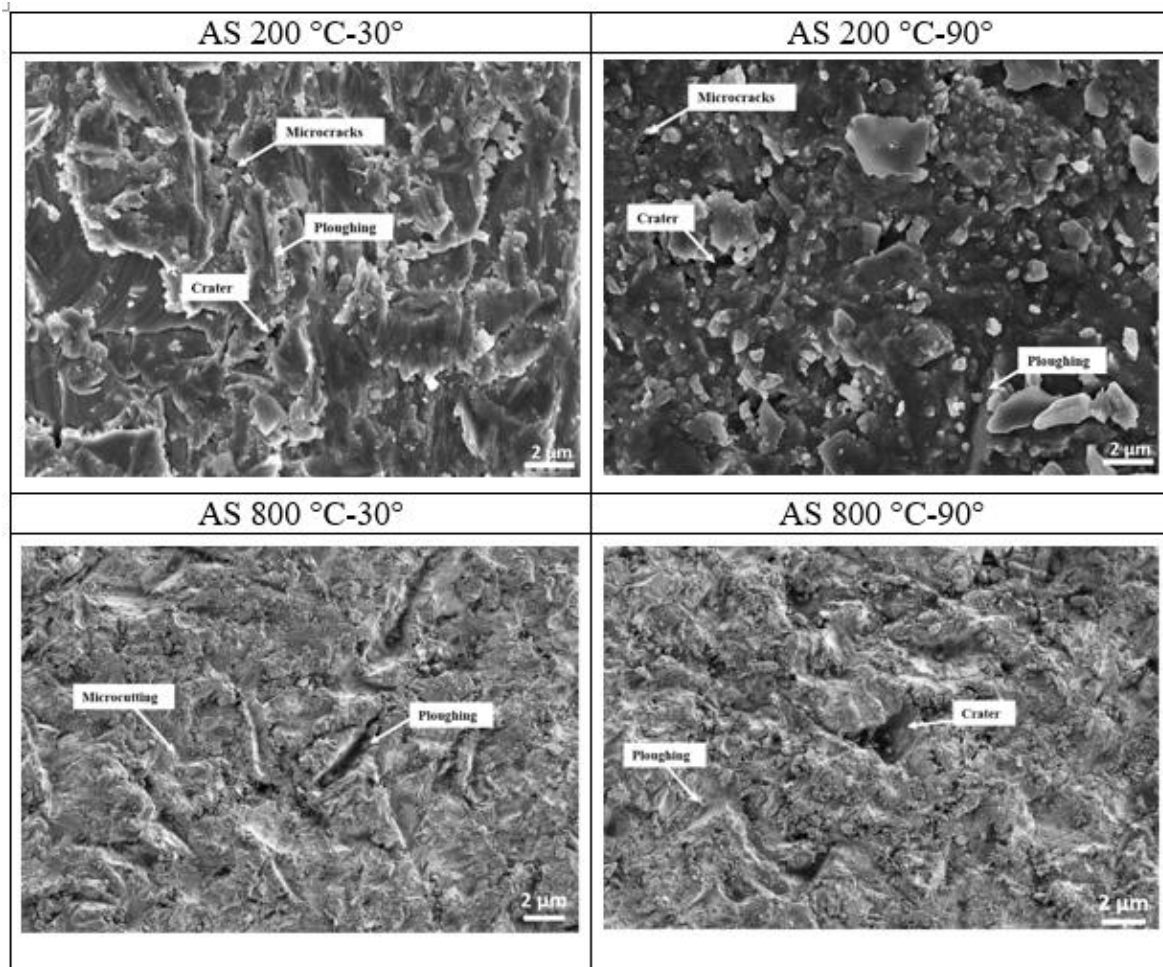
Figure 5.30 High magnification SEM images of as-coated samples exposed to various erosion conditions

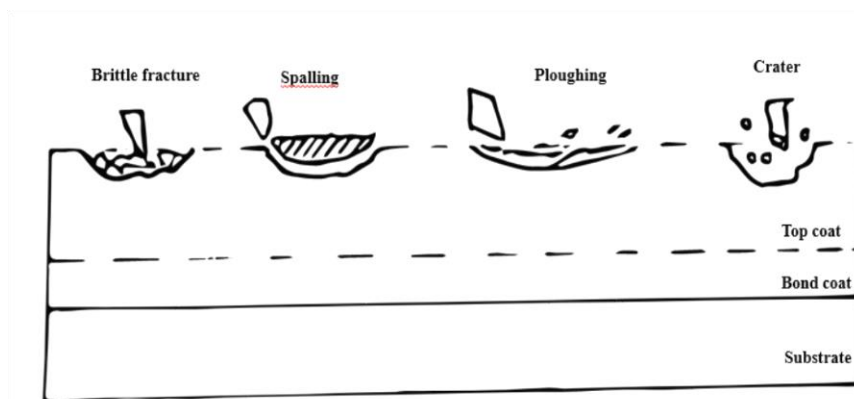
Figure 5.31 Schematic diagram of erosion mechanisms observed in the developed coating

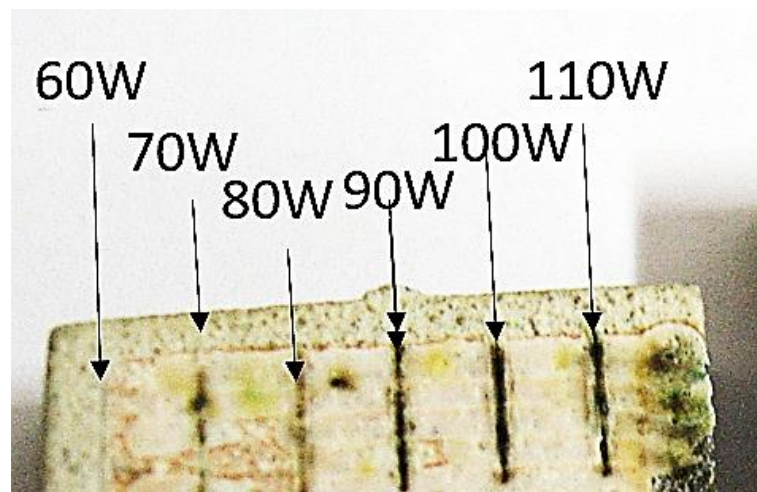
Figure 6.1 Image showing the burning marks on coating surface on exposure to laser beam with various power levels

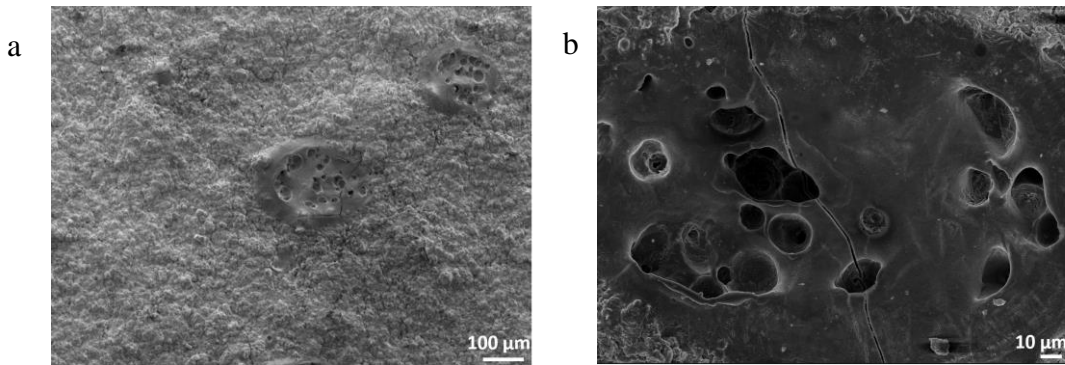
Figure 6.2 a) SEM image showing localized burning marks on samples treated with 60 W laser power, b) The high magnification view of the burned regions

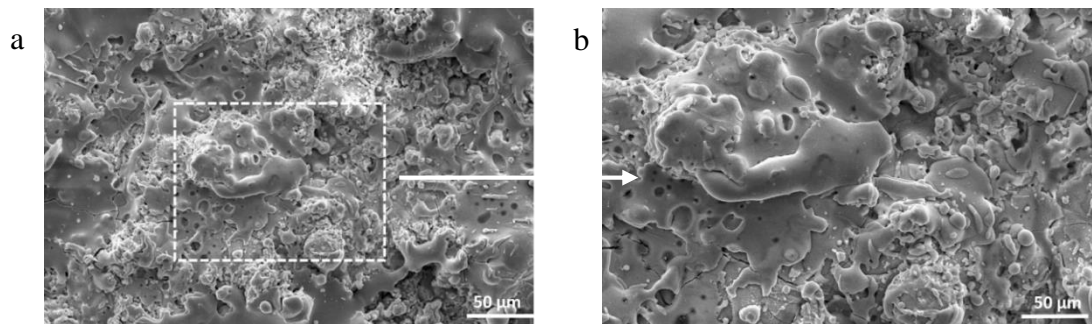
Figure 6.4 The surface of laser-treated specimen observed in SEM at different magnifications a) 500 X b) 1000 X

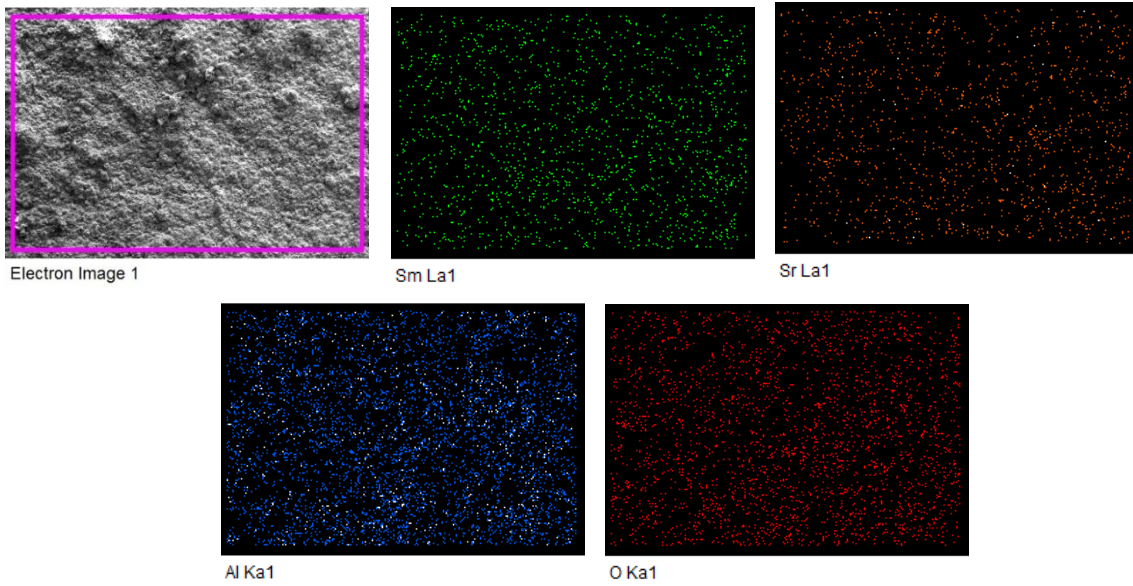
Figure 6.5 Elemental mapping of laser coated sample surface

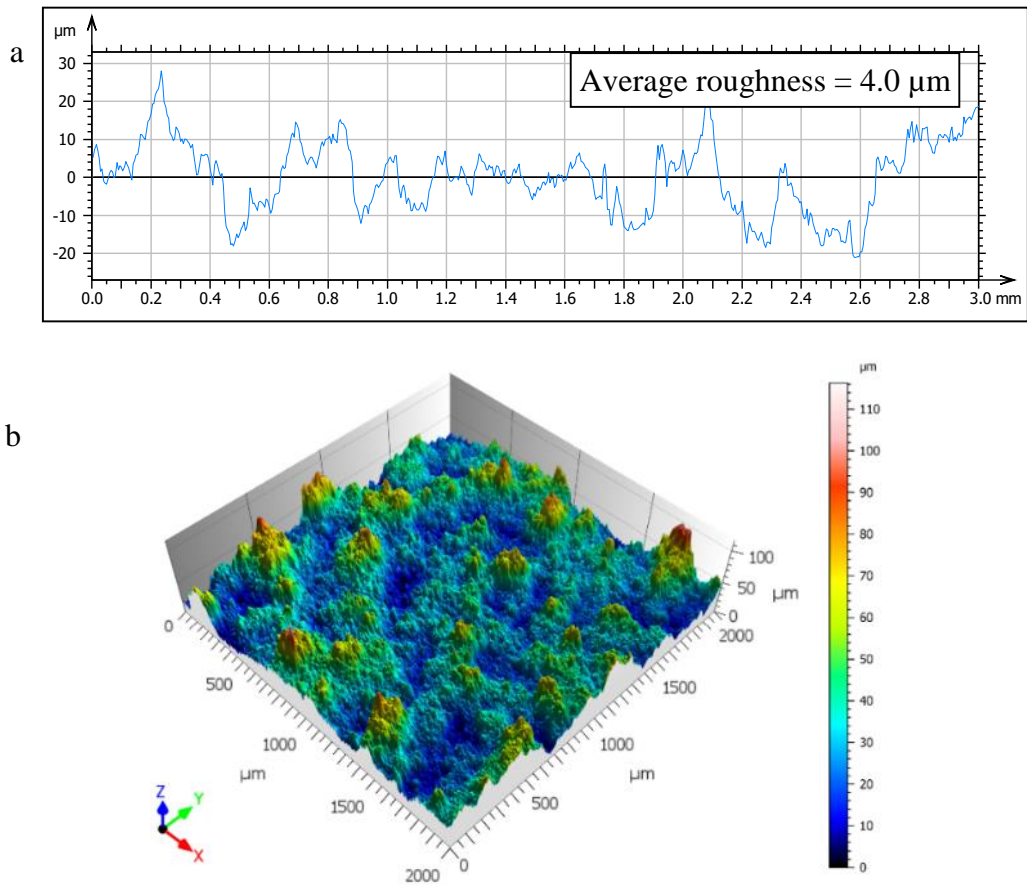
Figure 6.6 a) Surface roughness profile and b) profilometric image of laser-treated sample surface

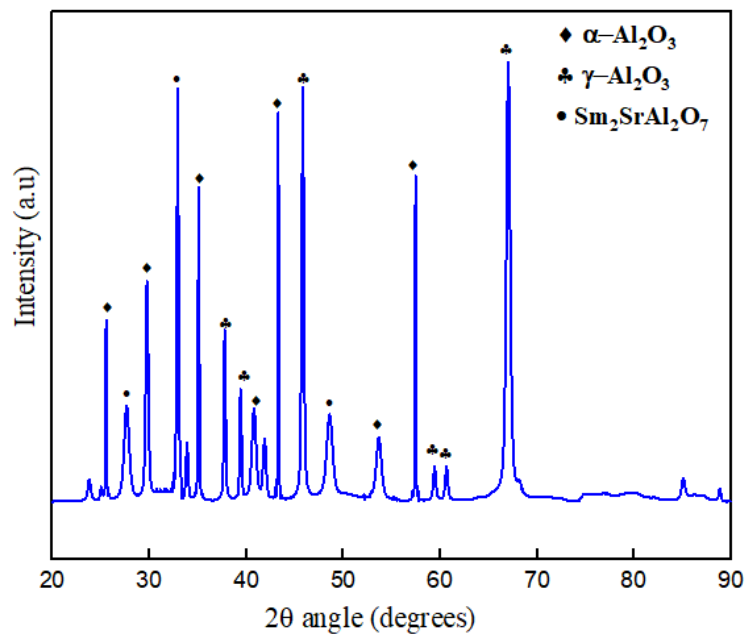
Figure 6.7 Surface XRD pattern of the laser-treated samples

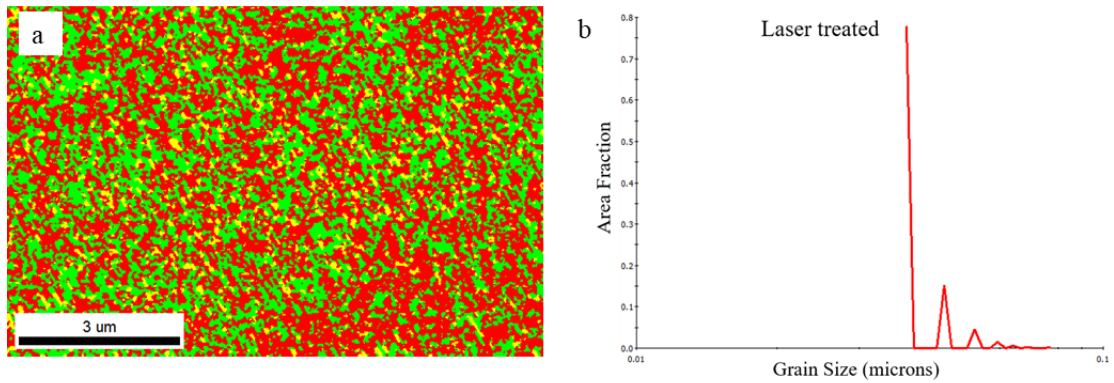
Figure 6.9 a) Phase map and b) grain size distribution of laser-treated samples

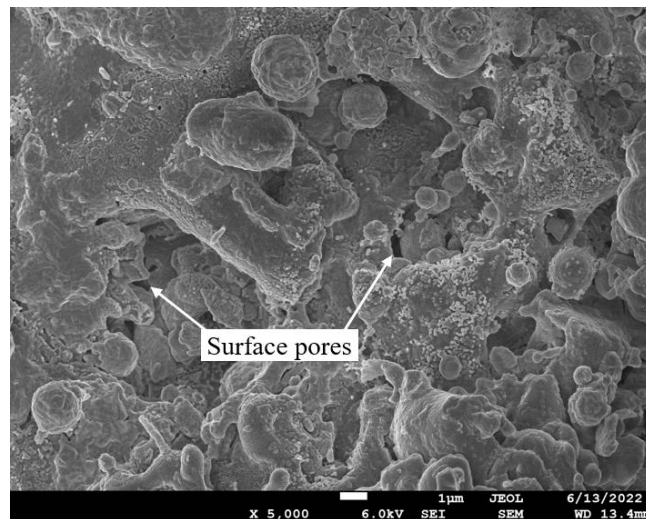
Figure 7.1 Surface image of laser-treated samples after isothermal oxidation at 1100 °C for 150 h

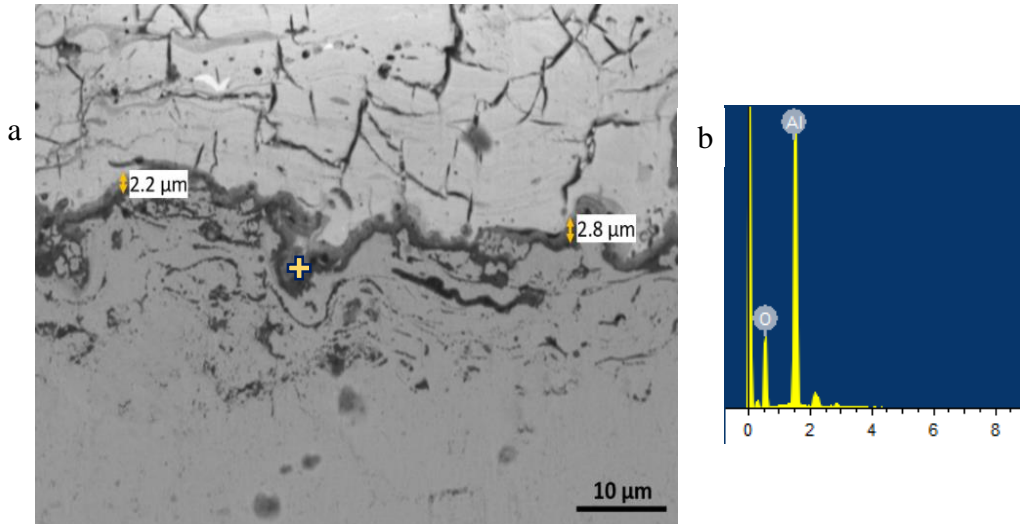
Figure 7.4 a) Cross-section of laser-treated coatings exposed to 30 h oxidation at 1100 °C b) EDS mapping of TGO region

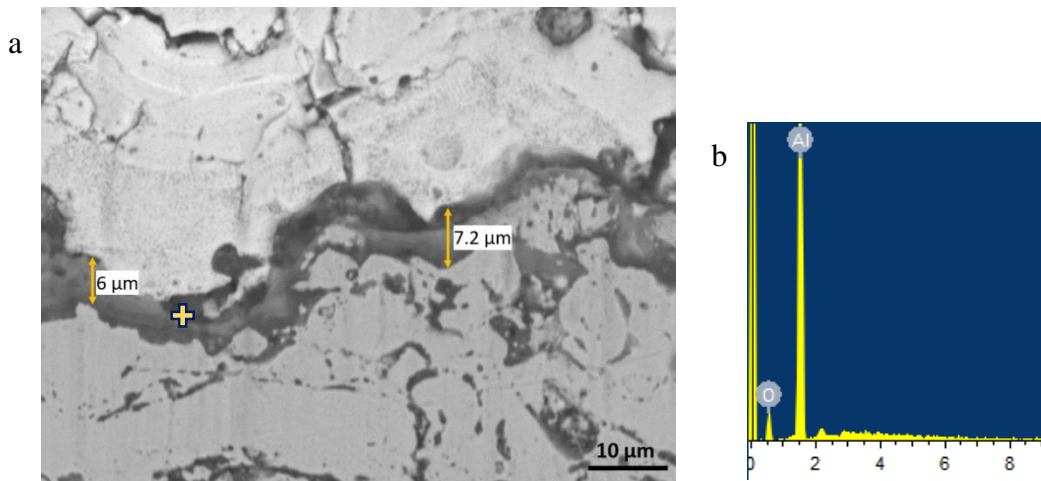
Figure 7.6 a) Cross-section of laser-treated coatings exposed to 150 h oxidation at 1100 °C b) EDS mapping of TGO region

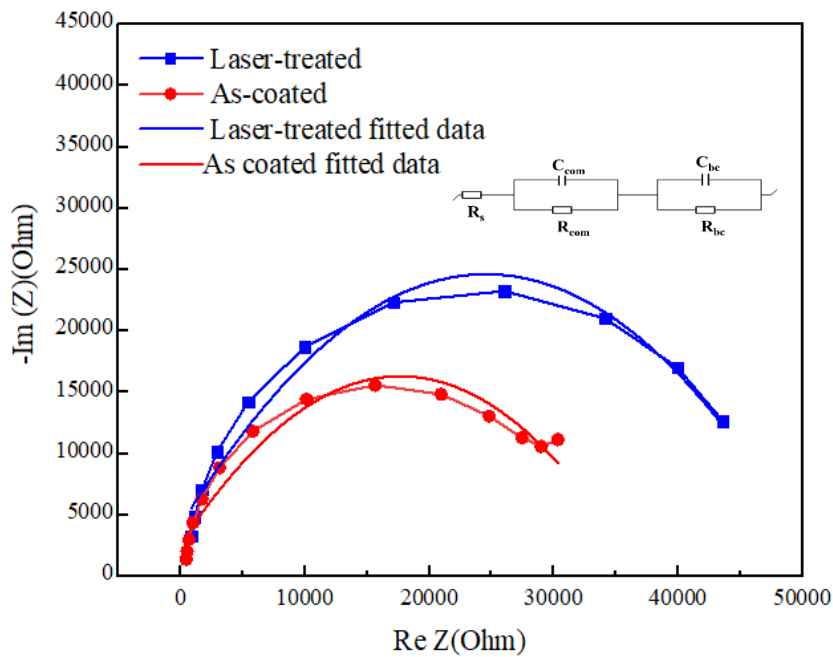
Figure 7.10 Nyquist plots for the as-coated and laser-treated samples

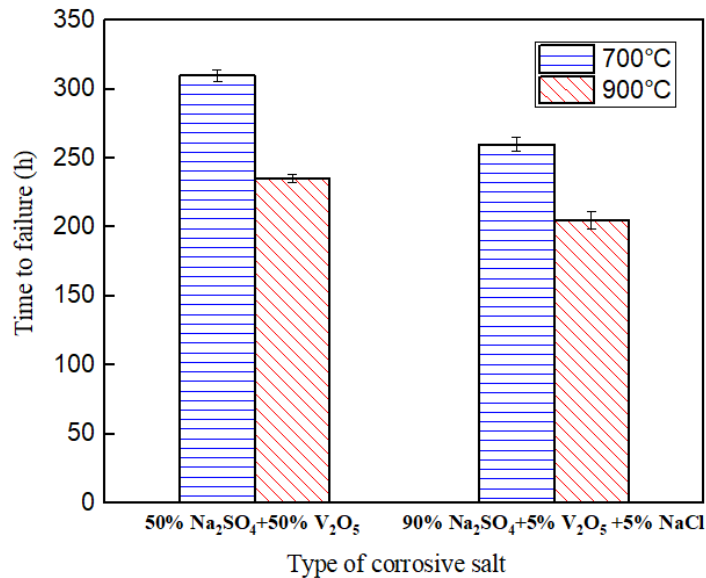
Figure 7.11 Hot corrosion resistances of laser-treated samples in different corrosive conditions

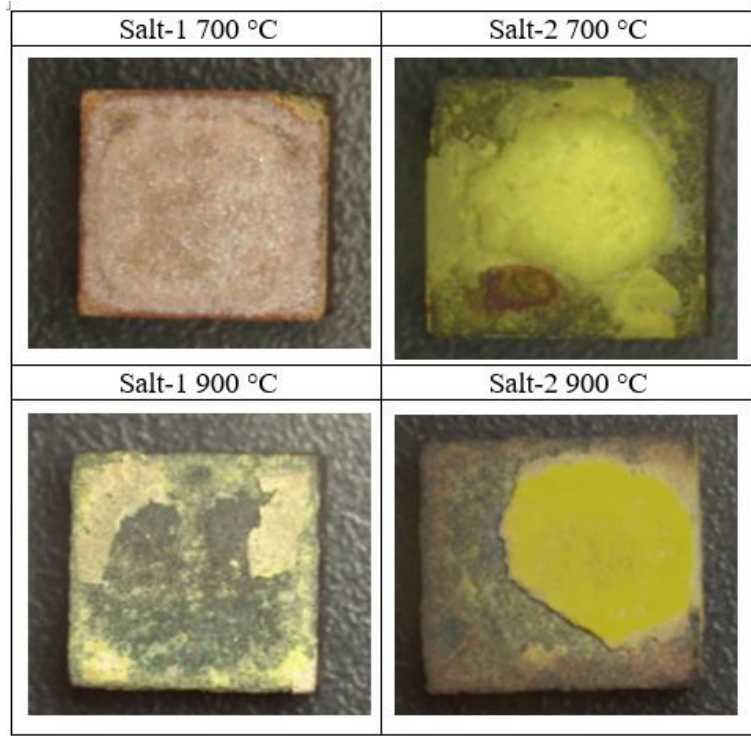
Figure 7.12 Photographs of laser-treated samples after hot corrosion in various conditions

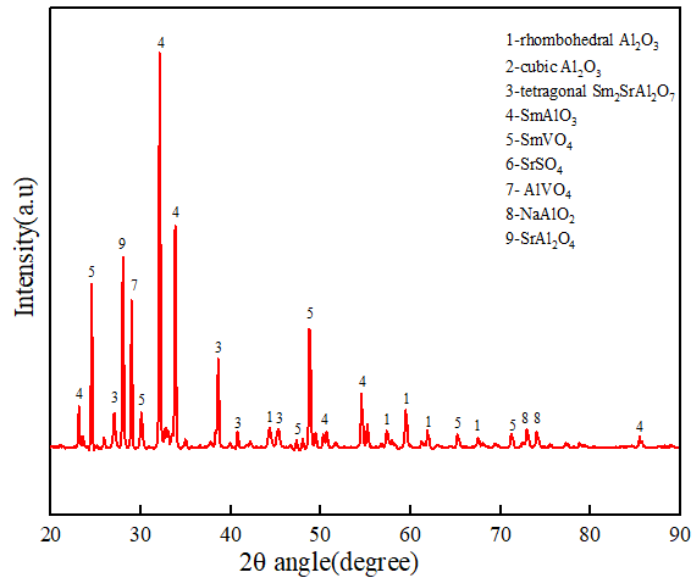
Figure 7.13 XRD pattern of laser-treated sample exposed to 50 % wt  $\text{Na}_2\text{SO}_4$  + 50 % wt  $\text{V}_2\text{O}_5$  at 700 °C

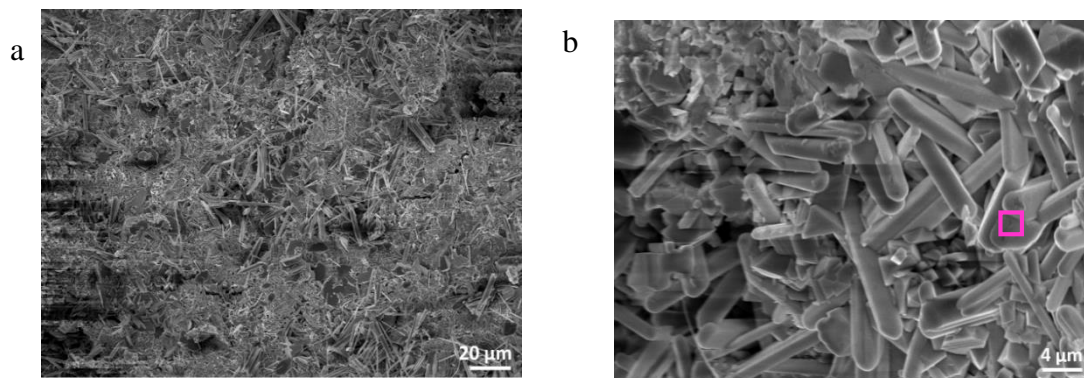
Figure 7.14 The SEM morphology of laser-treated samples exposed to 50 % wt  $\text{Na}_2\text{SO}_4$  + 50 % wt  $\text{V}_2\text{O}_5$  at 700 °C showing  
a) Low magnification image of corroded surface  
b) High magnification image of the hot corrosion products formed on surface

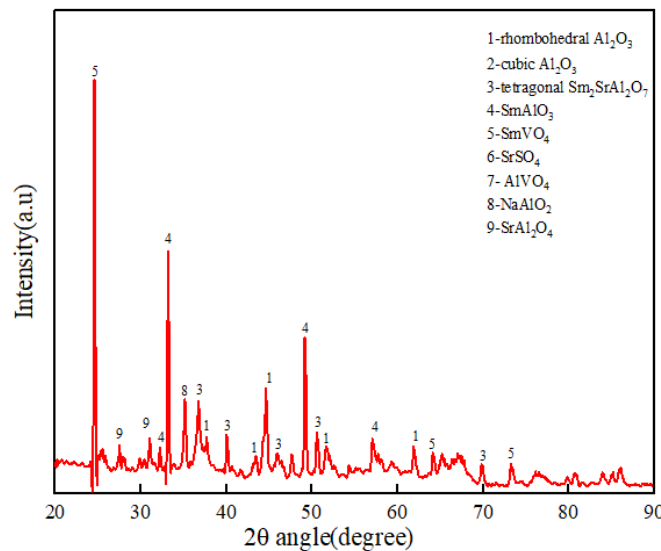
Figure 7.15 XRD pattern of laser-treated sample exposed to 50 %wt Na<sub>2</sub>SO<sub>4</sub> + 50 %wt V<sub>2</sub>O<sub>5</sub> at 900 °C

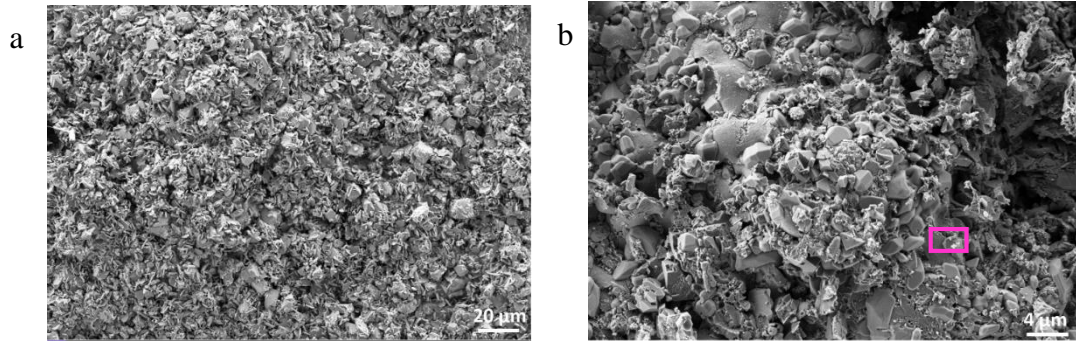
Figure 7.16 The SEM morphology of laser-treated samples exposed to 50 %wt Na<sub>2</sub>SO<sub>4</sub> + 50 %wt V<sub>2</sub>O<sub>5</sub> at 900 °C showing  
a) Low magnification image of corroded surface  
b) High magnification image of the hot corrosion products formed on surface

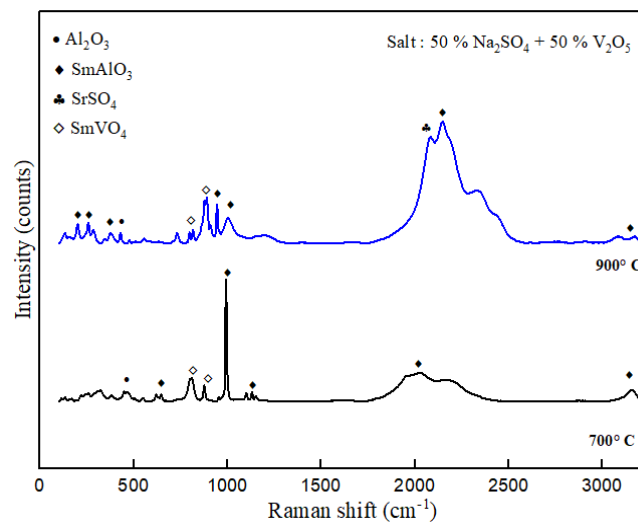
Figure 7.17 Raman spectrum of laser-treated samples after hot corrosion tests at 50 % wt. Na<sub>2</sub>SO<sub>4</sub> + 50 % wt. V<sub>2</sub>O<sub>5</sub> at 700 °C and 900 °C

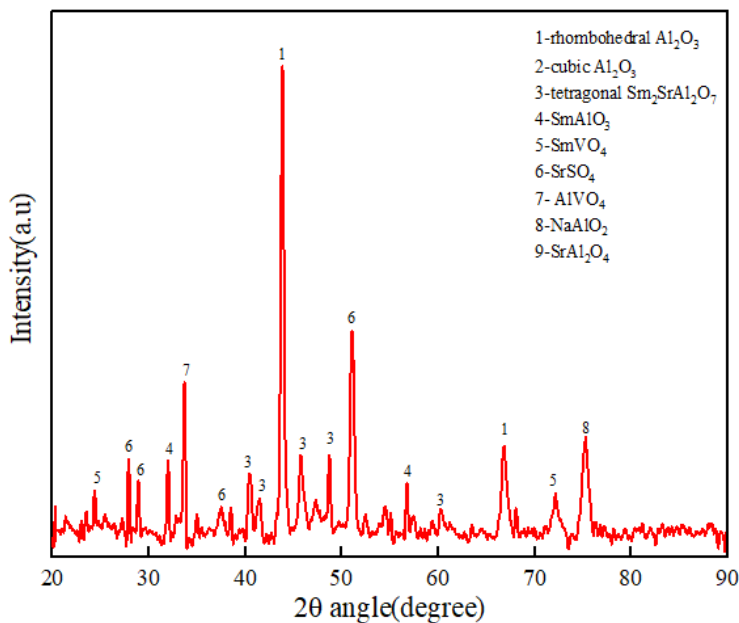
Figure 7.18 XRD pattern of laser-treated sample exposed to 90 % wt Na<sub>2</sub>SO<sub>4</sub> + 5 % wt V<sub>2</sub>O<sub>5</sub> + 5 %wt NaCl at 700 °C

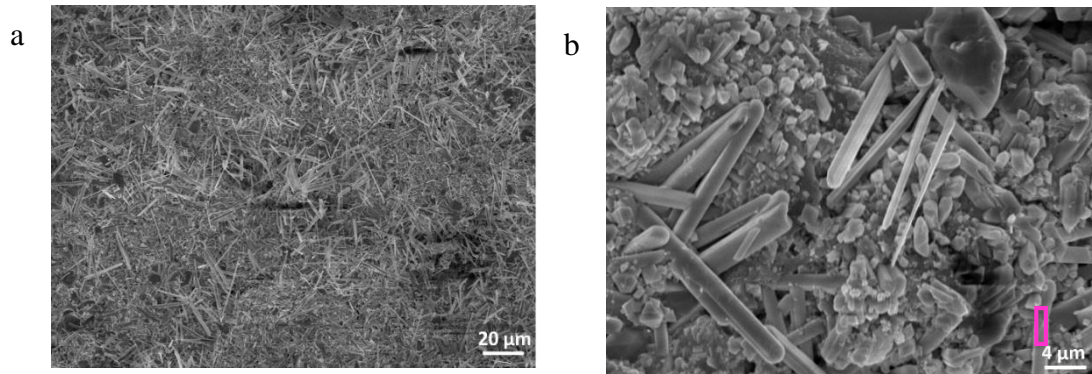
Figure 7.19 The SEM morphology of laser-treated samples exposed to 90 % wt.  $\text{Na}_2\text{SO}_4$  + 5 % wt.  $\text{V}_2\text{O}_5$  + 5 % wt.  $\text{NaCl}$  at 700 °C showing  
a) Low magnification image of corroded surface,  
b) High magnification image of the hot corrosion products formed on surface

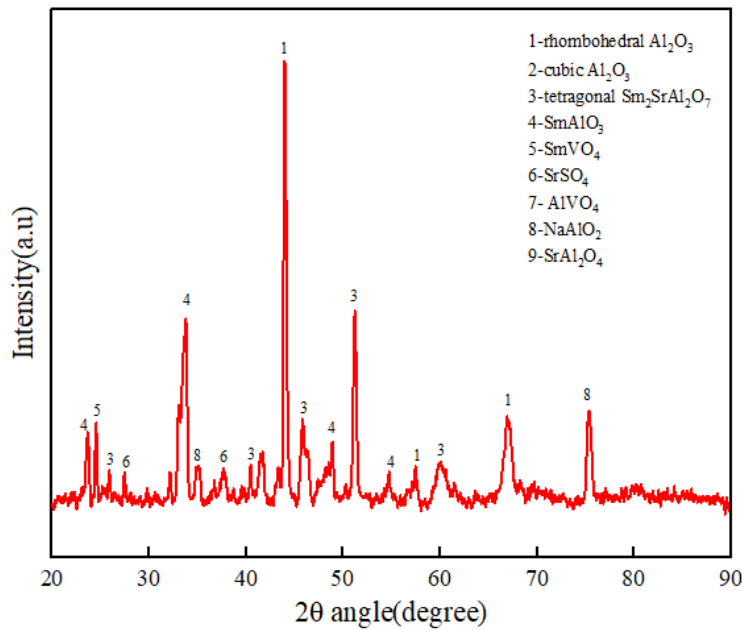
Figure 7.20 XRD pattern of laser-treated sample exposed to 90 % wt.  $\text{Na}_2\text{SO}_4$  + 5 % wt.  $\text{V}_2\text{O}_5$  + 5 % wt.  $\text{NaCl}$  at 900 °C

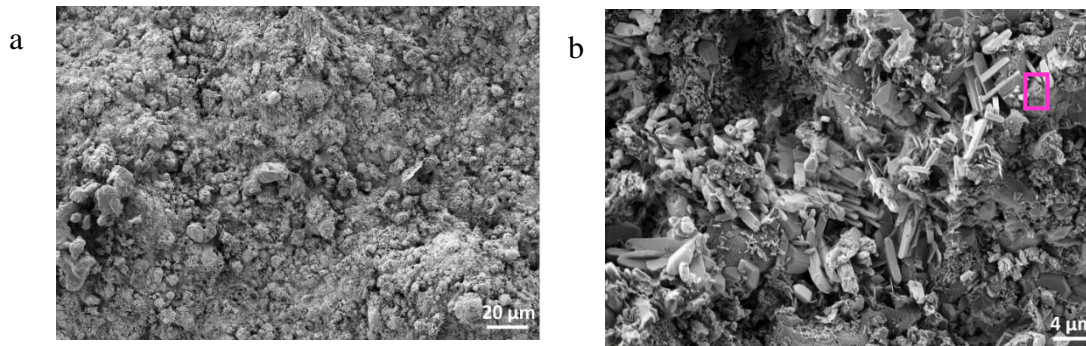
Figure 7.21 The SEM morphology of laser-treated samples exposed to 90 % wt.  $\text{Na}_2\text{SO}_4$  + 5 % wt.  $\text{V}_2\text{O}_5$  + 5 % wt.  $\text{NaCl}$  at 900 °C showing  
a) Low magnification image of corroded surface  
b) High magnification image of the hot corrosion products formed on surface

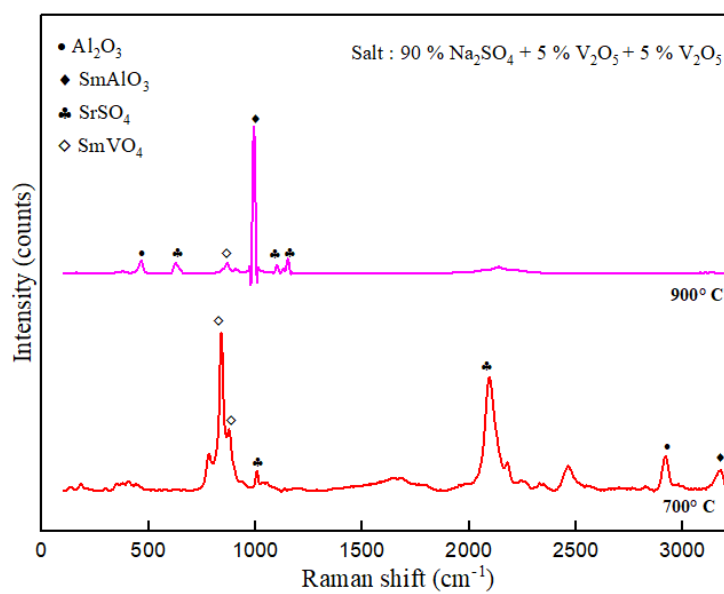
Figure 7.22 Raman spectrum of laser-treated samples after hot corrosion tests at 90 % wt Na<sub>2</sub>SO<sub>4</sub> + 5 % wt V<sub>2</sub>O<sub>5</sub> + 5 % wt NaCl at 700 °C and 900 °C

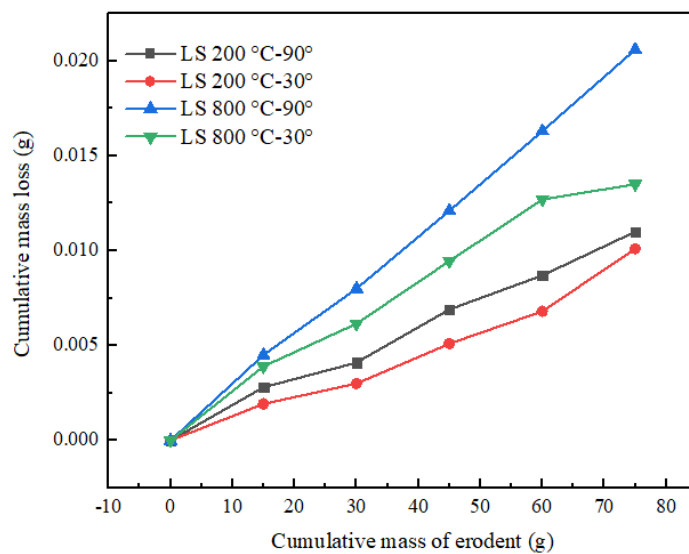
Figure 7.24 Graph showing cumulative mass loss of coating vs cumulative mass of erodents for laser-treated samples exposed at 200 °C and 800 °C

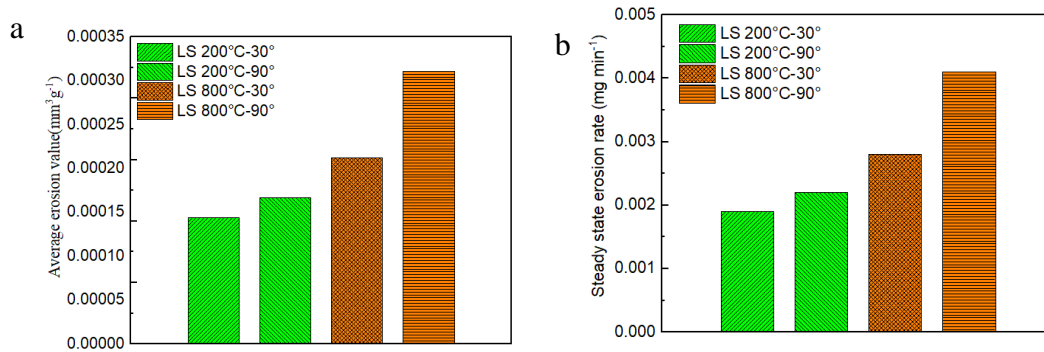
Figure 7.26 Plots showing a) average erosion values and b) steady state erosion rate of laser-treated samples at different conditions

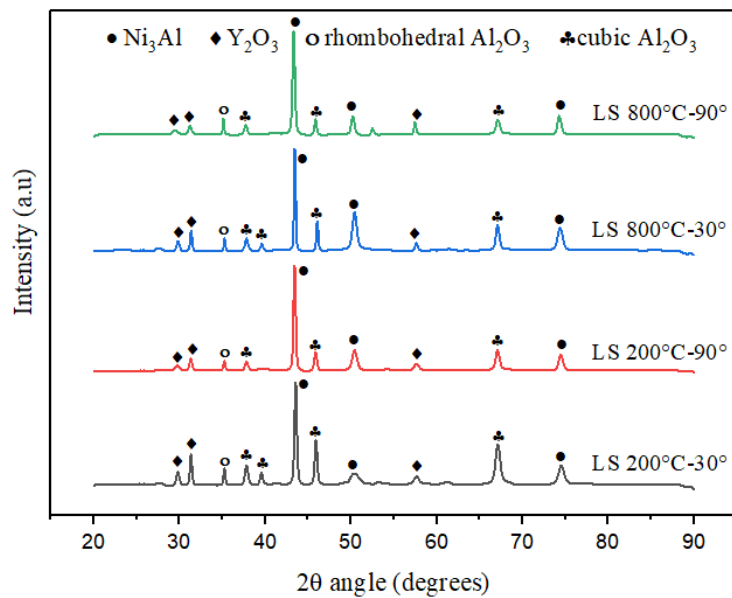
Figure 7.27 XRD patterns of scars in laser-treated samples eroded at various conditions

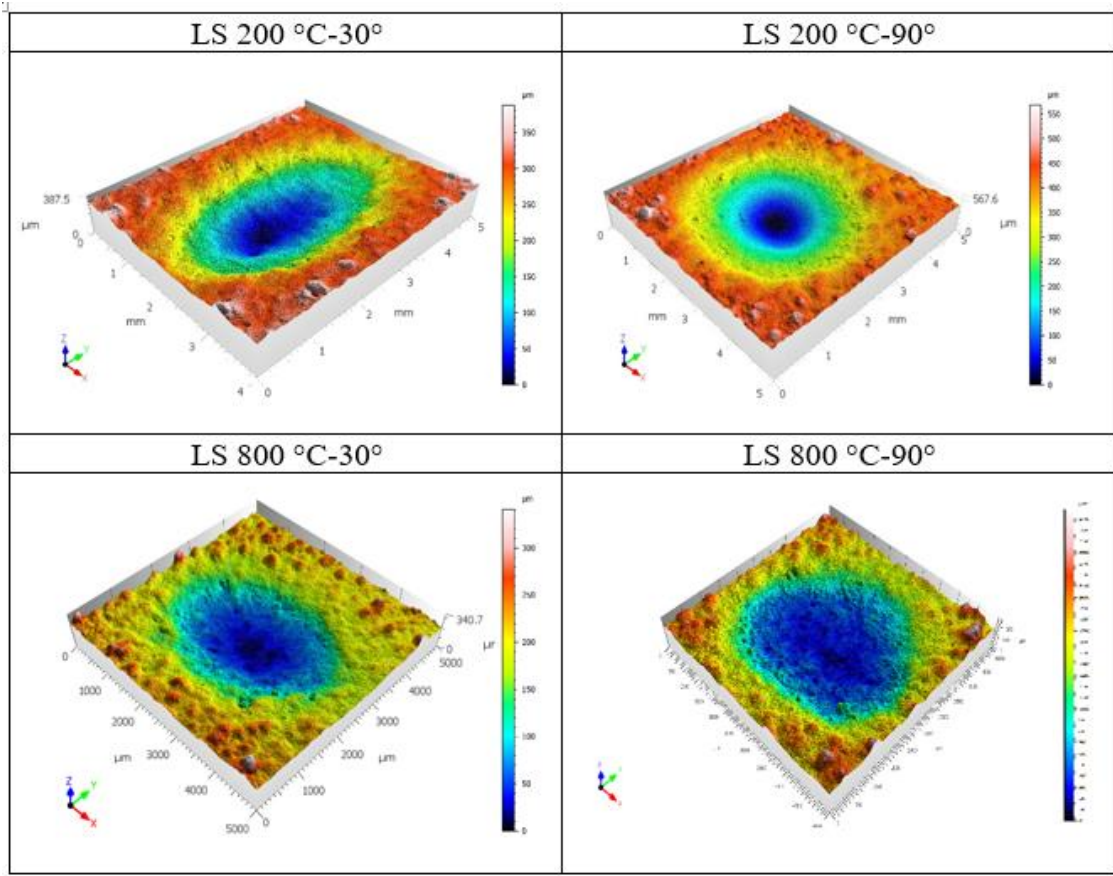
Figure 7.28 Profilometric view of eroded areas in laser-treated samples

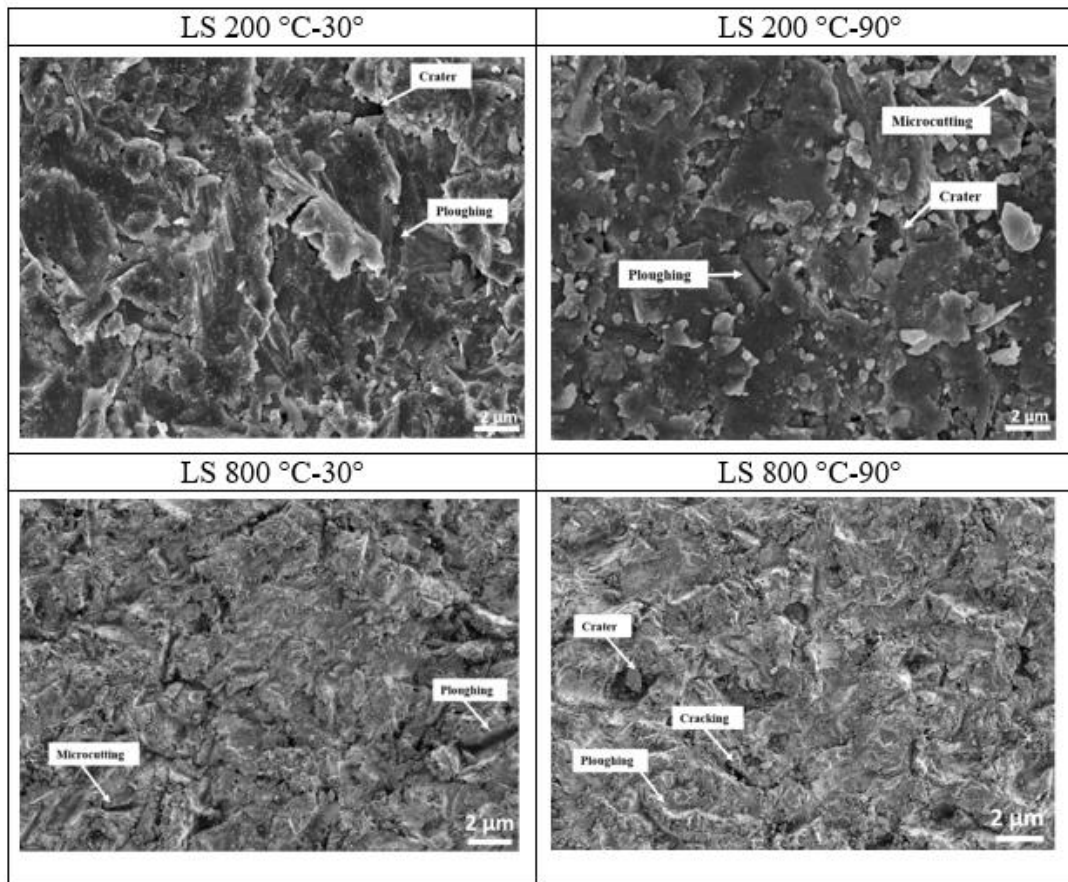
Figure 7.29 High magnification SEM images of laser-treated samples exposed to various erosion conditions

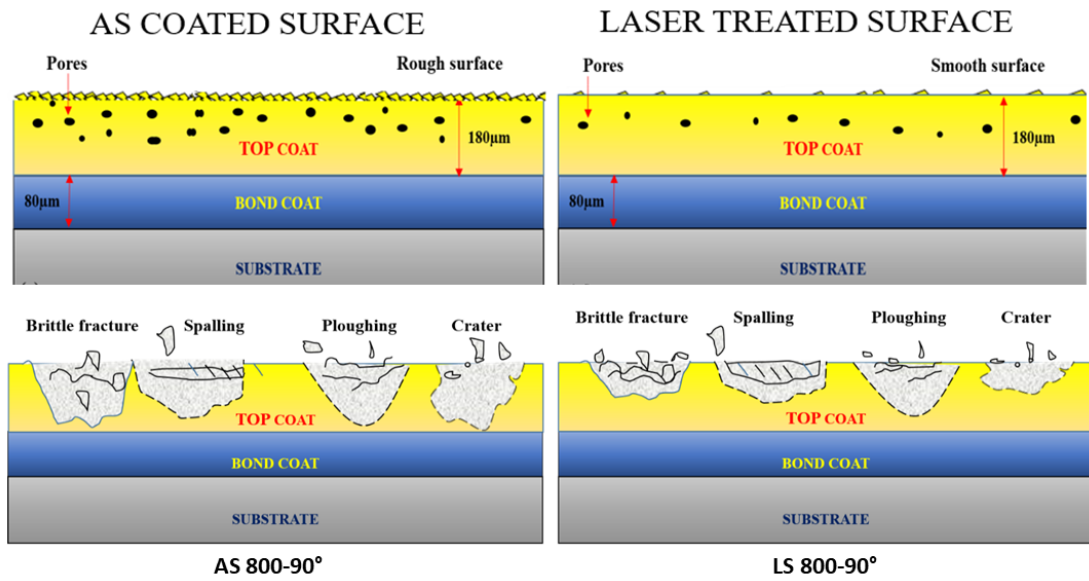
Figure 7.30 Schematic diagram of erosion mechanisms observed in as-coated and laser-treated samples at 800 °C (not in scale)
